Site and Facility Assessment For Ulu Ke Kukui Transitional Housing

Wai'anae, O'ahu, Hawai'i
87-576 Kula'aupuni Street
TMK: (1) 8-7-010:030

October 31, 2017 (FINAL)

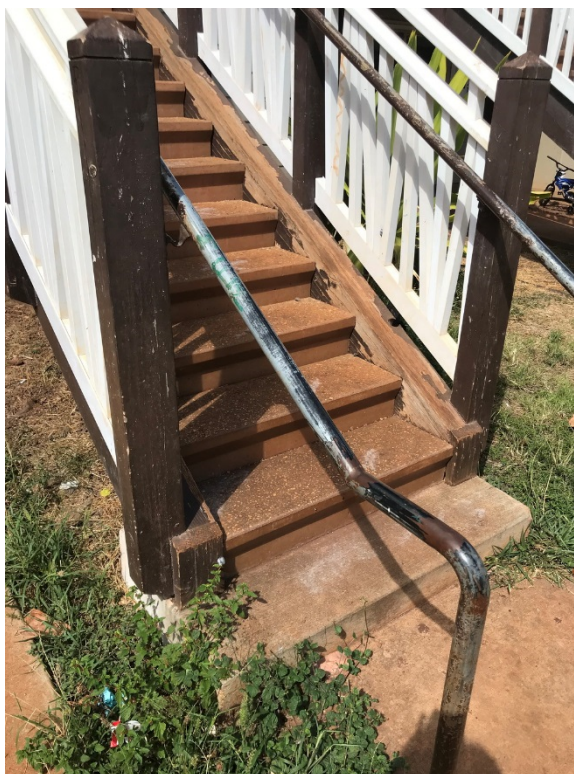
- General Quality of Construction and Condition:
 - The buildings were designed and constructed to an adequate level of quality. The buildings are wood framed structures which have a predictable history of performance in the tropical marine environment. Many areas of exterior finish degradation were observed. **(See Photo 1.2)**

Photo 1.2. Exterior Finish

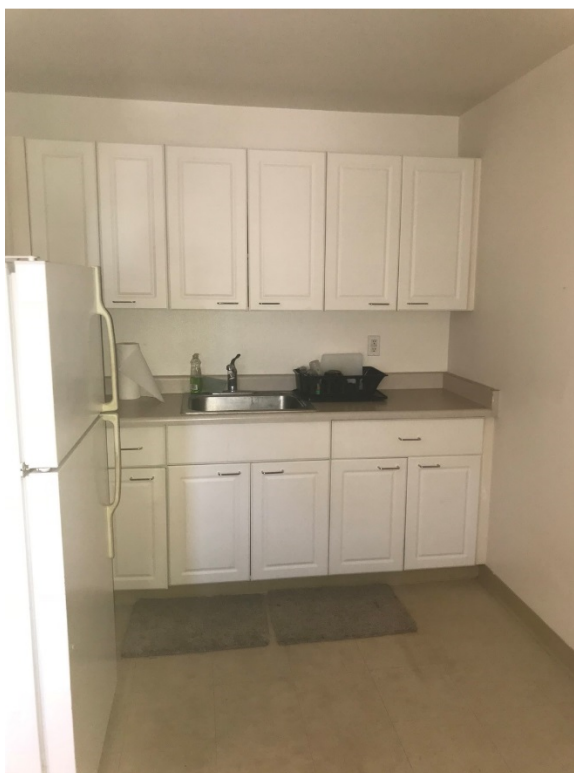
- In general, the interior of units observed were generally in good condition with no indication of wall, ceiling or flooring failures, or damages. **(See Photo 1.3)**

Photo 1.3. Interior of Building

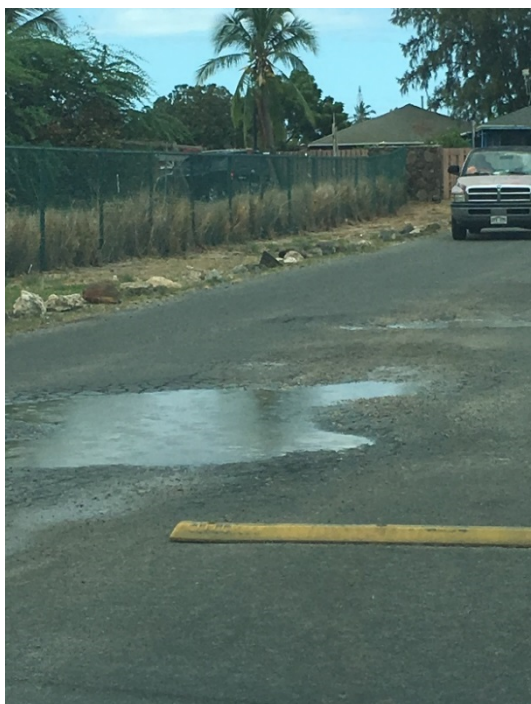
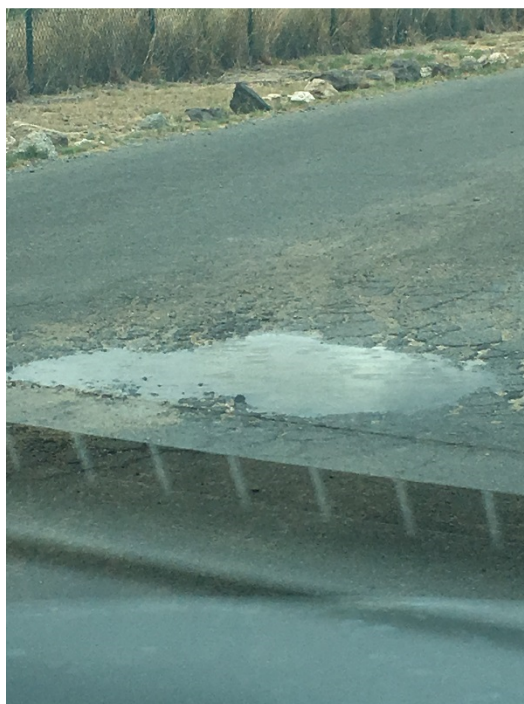
- Access to the site is provided through Holt Road from the City and County of Honolulu owned Kula'āupuni Street. Holt Road consists of a two-lane asphalt paved driveway. The driveway appears to be DHHL-owned per property tax maps. Holt Road also provided access to Ho'omalū O Na Kamali'i operated by Family Programs Hawaii. Asphalt cracking and potholes were observed at several locations along the driveway to the facility indicating the pavement is failing. Towards the entrance of Holt Road, two deep depressions on the asphalt road on one side of the lane about 6-in deep. (See Photo 2.1). There is a low point on the south-eastern side

Photo 2.1. Holt Road, Asphalt Concrete Depression

a. Remove and repave asphalt areas	\$24,406
b. Remove and repave concrete sidewalk	\$2,261
c. Remove sign post and patch AC pavement:	\$515
d. Mobilization/Demobilization:	\$1,360

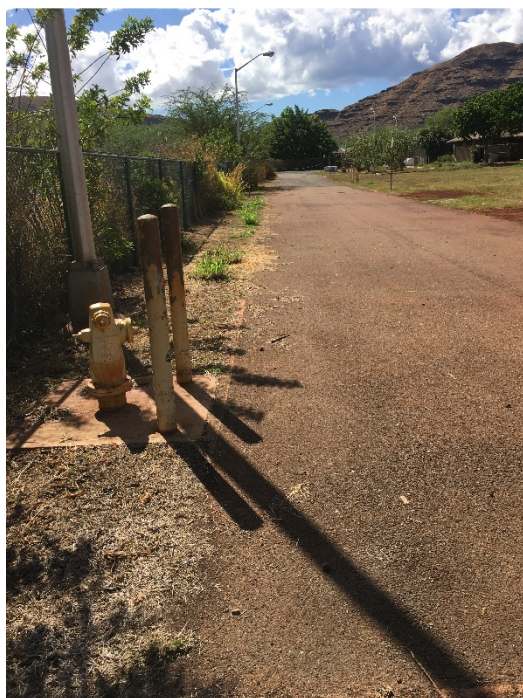
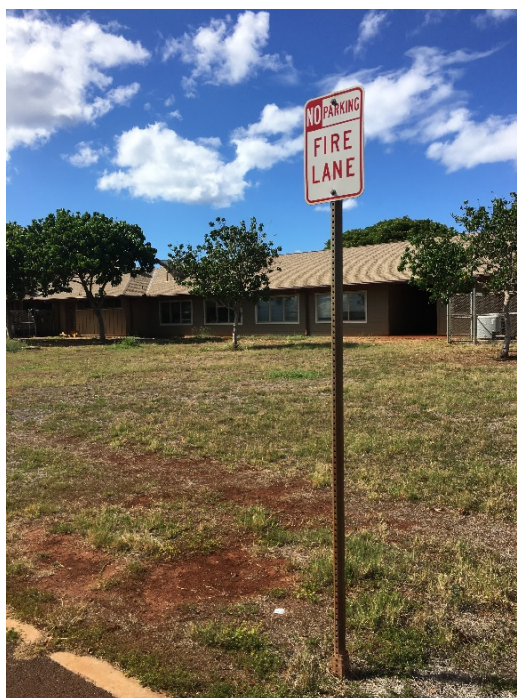
- There are 131 open parking stalls and 10 ADA designated parking stalls, which meet parking requirements. There are two large asphalt paved parking areas with two-way traffic located at the south and west sides of the facility. There is also a asphalt driveway to the east of the facility. **(See Photo 2.2)**.

Photo 2.2. Fire Lane

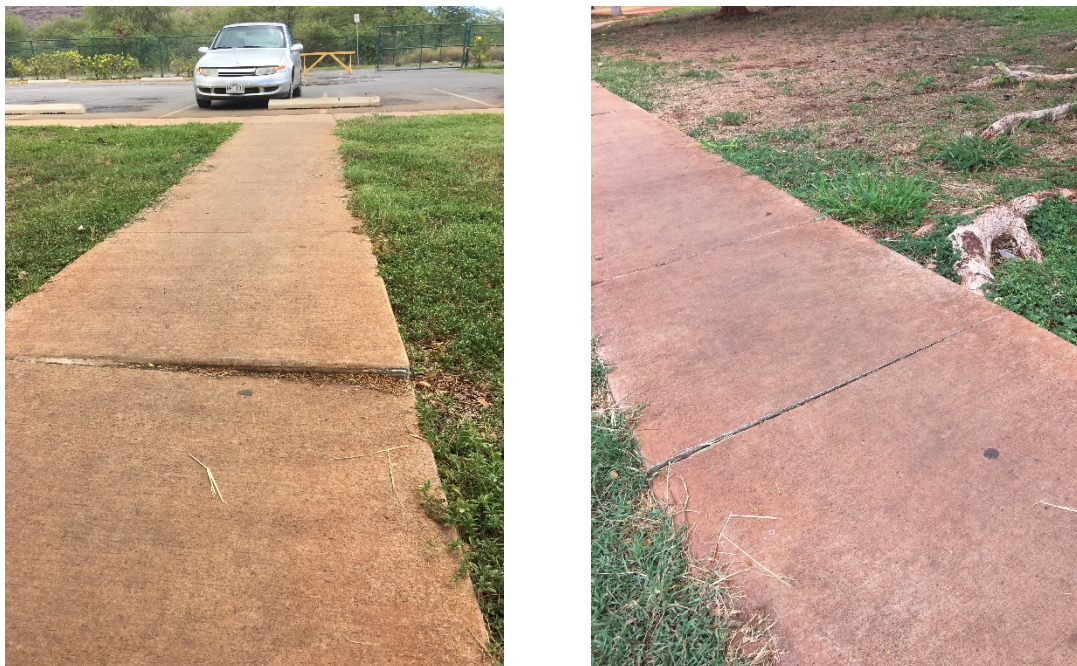
- The site is flat and appears to have ADA accessible paths connecting all buildings. There was an uneven sidewalk section which appeared to be caused by a nearby tree root about 10 feet in length. **(See Photo 2.3)**. Due to the condition of the pavement, ADA accessibility should be verified, and pavements should be repaired.

Photo 2.3. Uneven Pavement

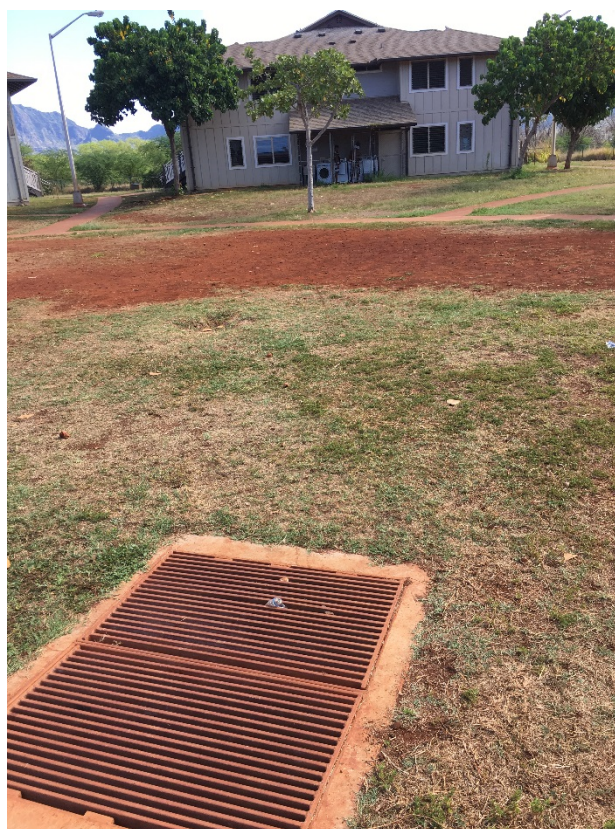
Photo 2.4. Drain Inlet in the Center of the Field

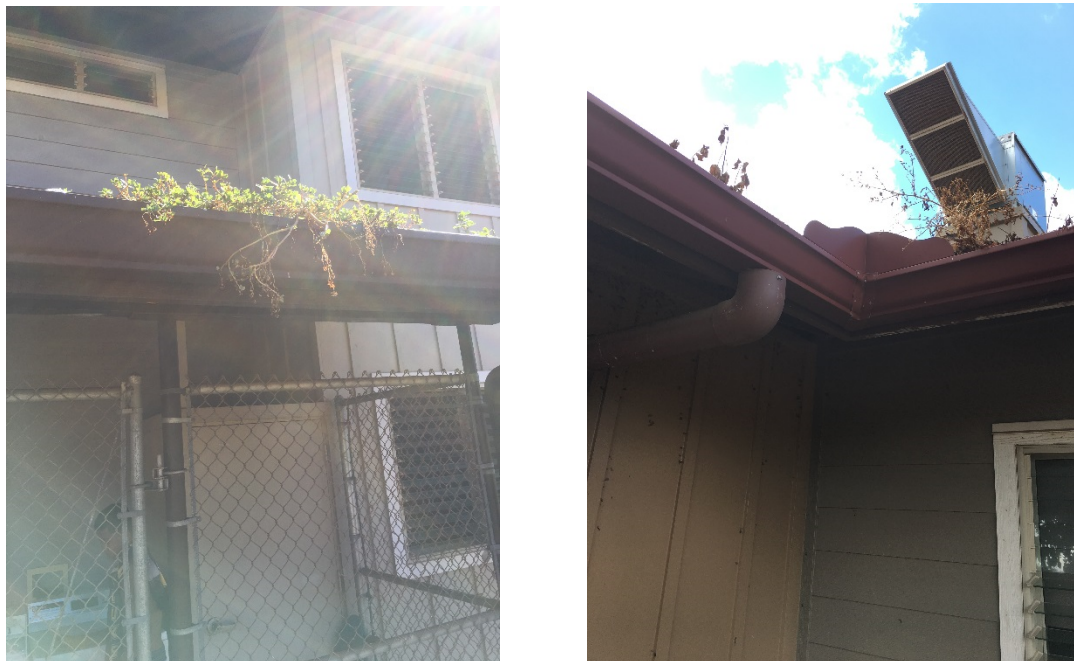
Photo 2.5. Debris in Gutters

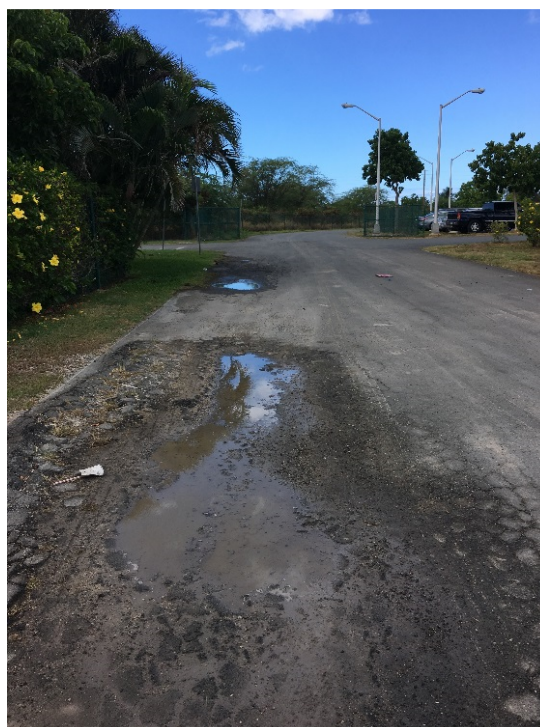
of the site along Holt Road causing rutting and asphalt cracking, it is approximately 10 feet in length causing significant failure. **(See Photo 2.6)**. There is ponding along the parking entrance and fire lane entrance about 8 feet in length as well as weeds growing out of the asphalt area. **(See Photo 2.7)**. Potholes and asphalt cracking were spotted in the parking lot due to ponding water and puddles close to 5 feet in diameter. **(See Photo 2.8)**. Asphalt deterioration appears near the fire lane on the west side of the parking lot. A detached sign post pole protrudes 1.5 inch from the ADA access stalls which will need to be removed. **(See Photo 2.9)**.

Photo 2.6. Rutting and Cracking

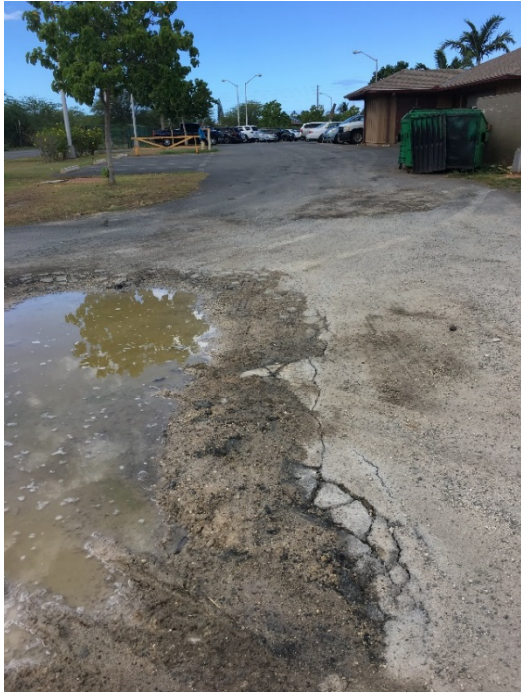
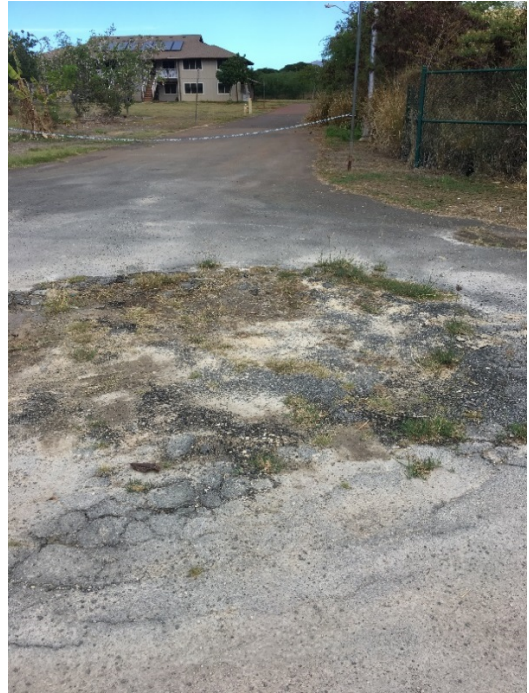
Photo 2.7. Ponding on Driveway

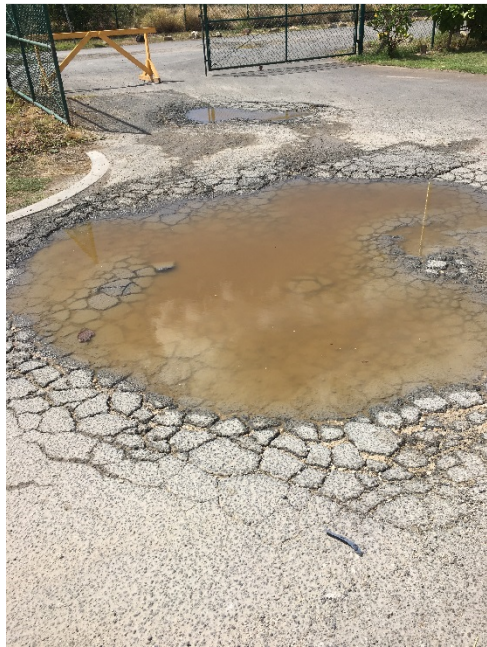
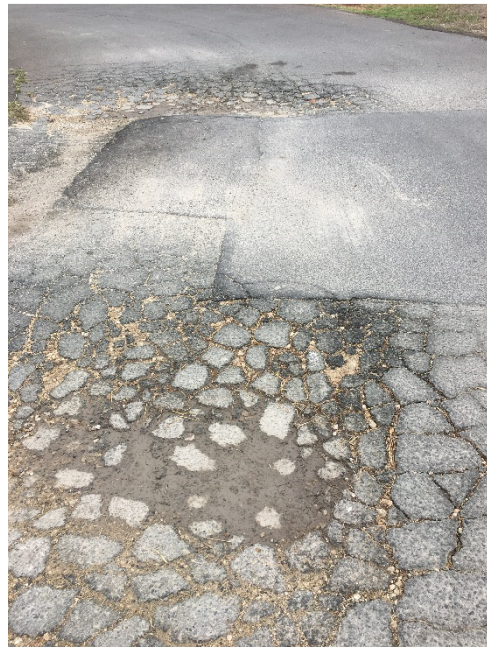
Photo 2.8. Potholes and Cracking on Parking Lot

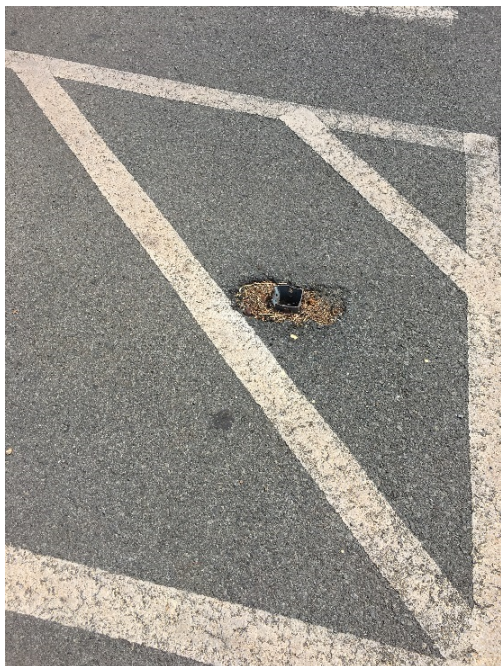
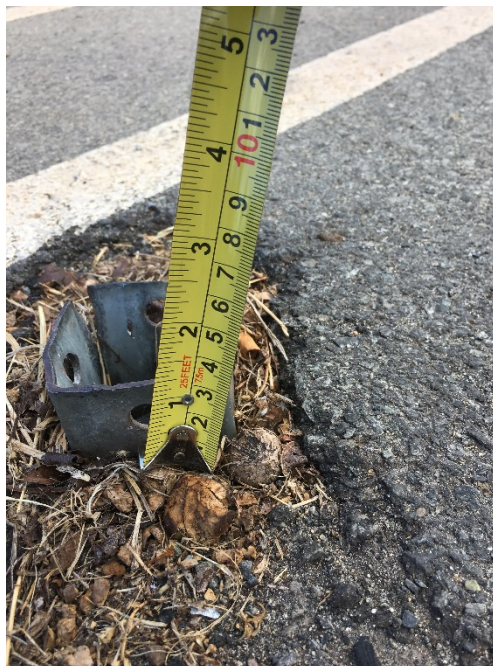
Photo 2.9. Sign Post

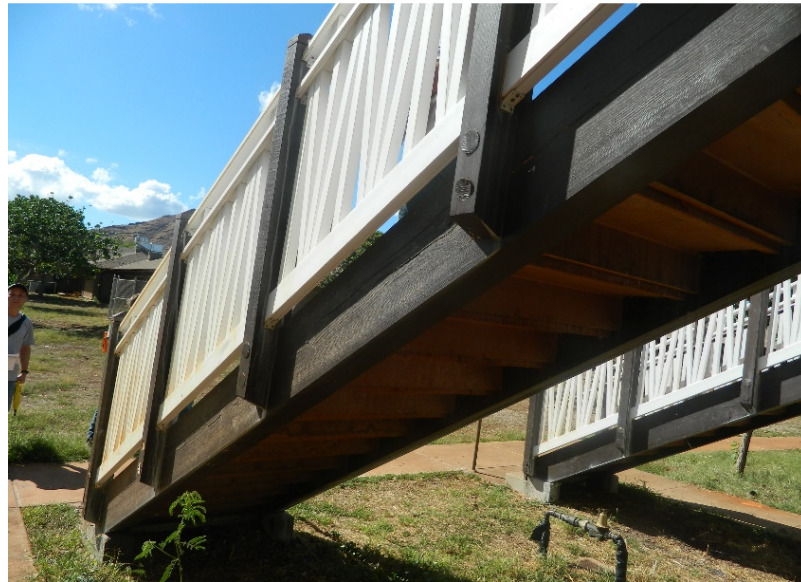
The exterior stairway up to the second floor is framed with precast concrete steps supported by Glulam beam stringers on each side. Wood railing posts are bolted to the outside faces of the stringers. (**See Photo 3.3**.)

Photo 3.3. Wood Railings Bolted Outside

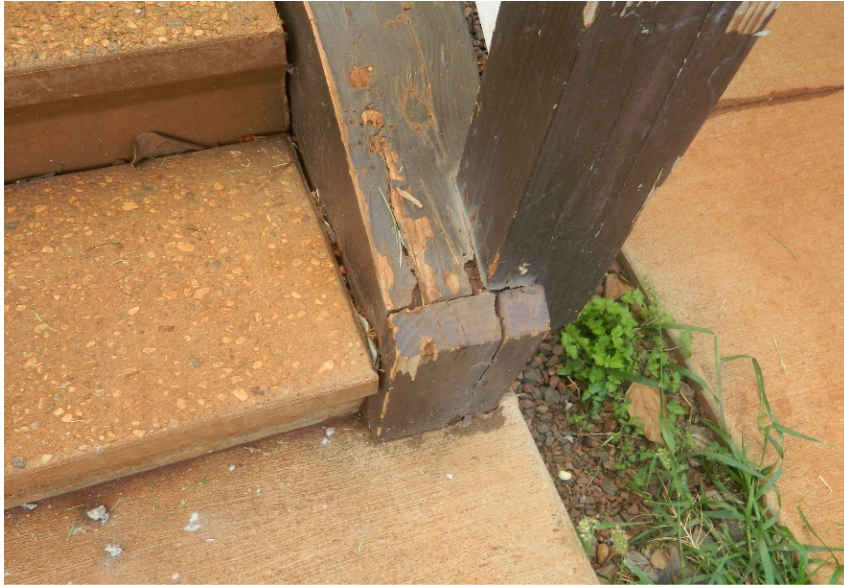
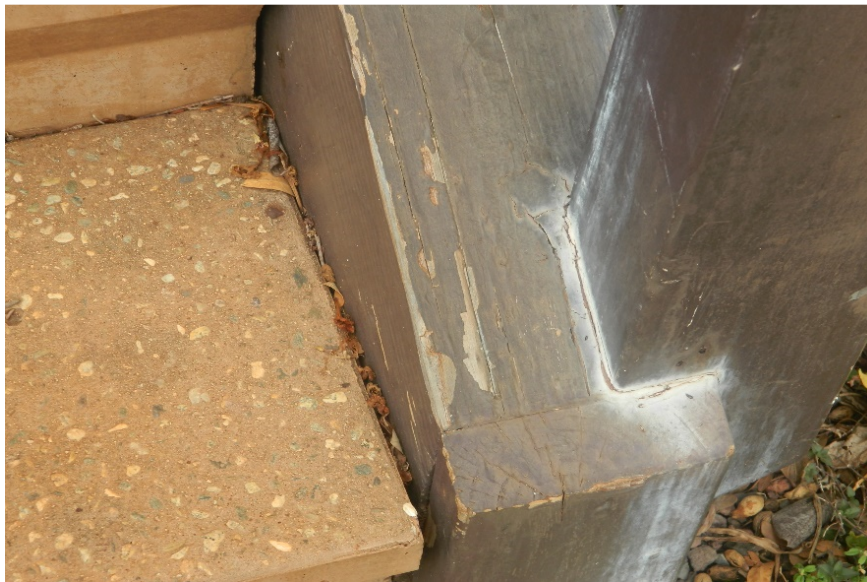
The stair framing post at the bottom landing fronting unit A102 and A107 was found with signs of rot with an approximate area of 6"x6" (**See Photo 3.4 and 3.5**). Need to notch out rot area and fill with structural epoxy and replace end piece to match existing. Paint over epoxy afterwards.

Photo 3.4. Stair Framing

Photo 3.5. Stair Framing

| a. Repair 6"x6" Stair framing post: | \$560 |

Repair 6"x6" Stair Framing Post, Unit 102	1	ls	\$25.00	\$25	\$255.00	\$255	\$280.00	\$280
Repair 6"x6" Stair Framing Post, Unit 107	1	ls	\$25.00	\$25	\$255.00	\$255	\$280.00	\$280

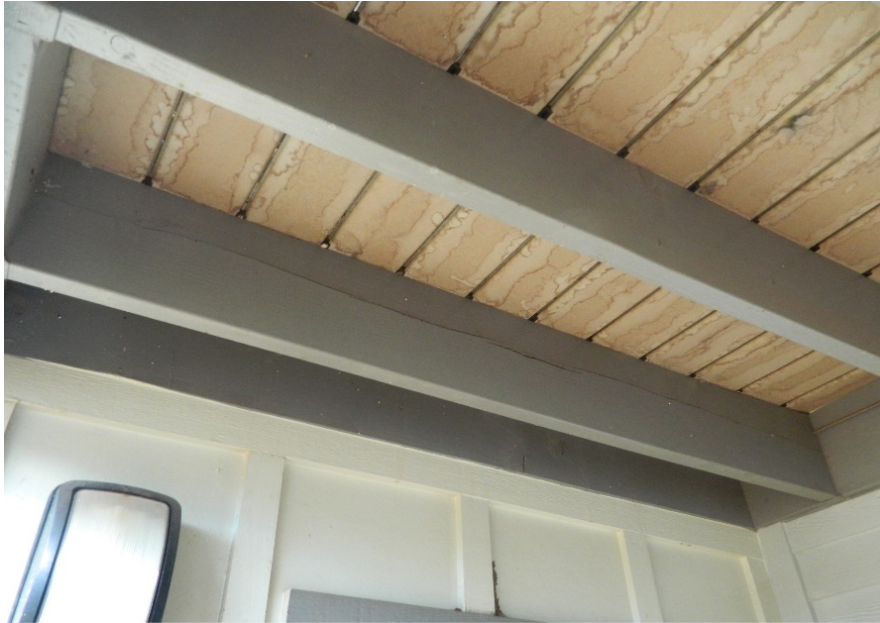
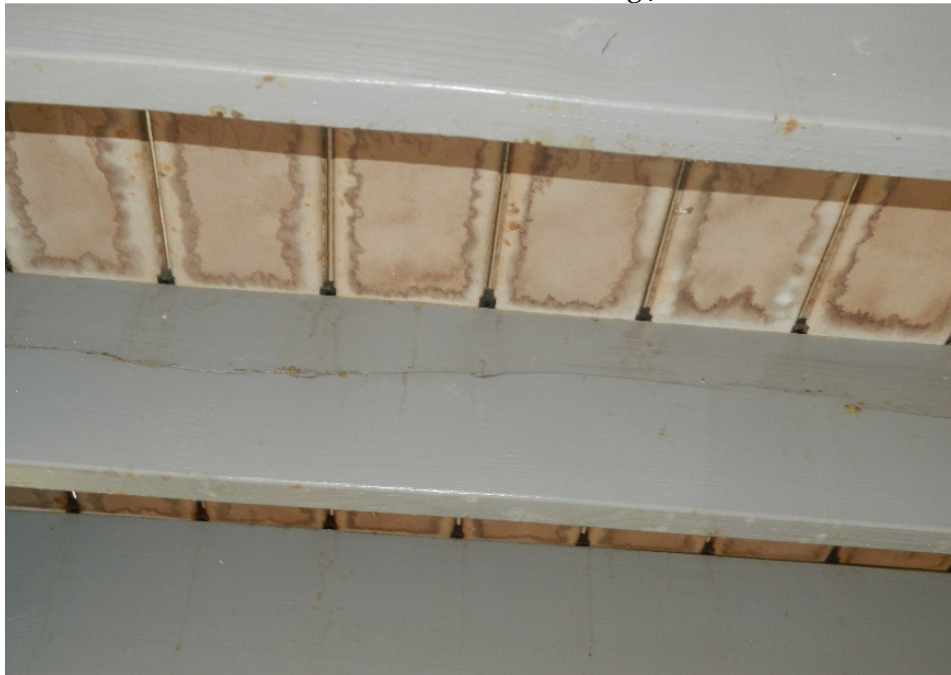
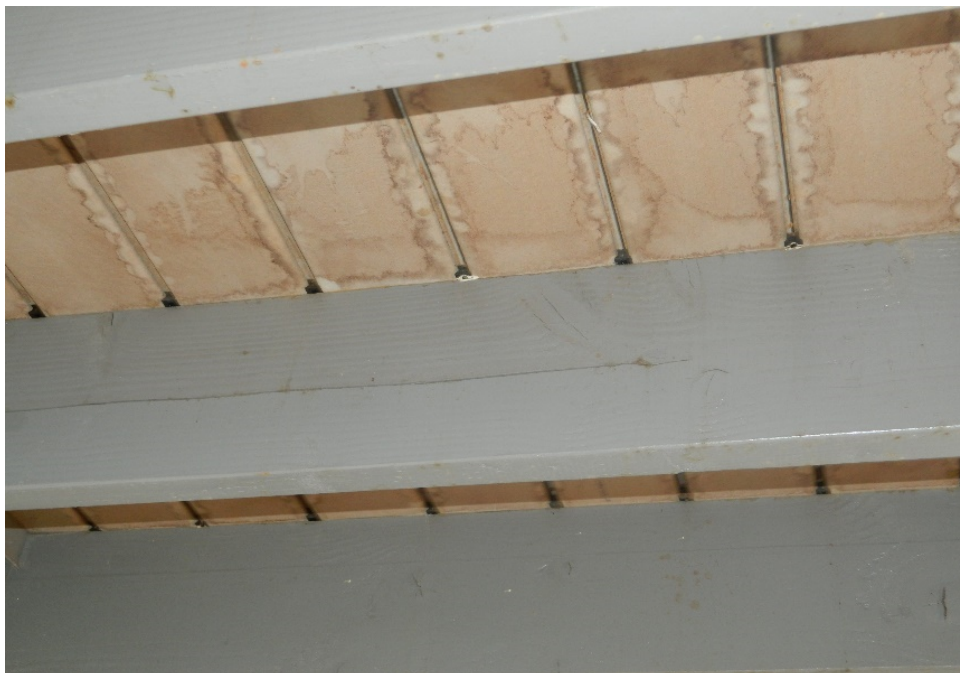
The exterior deck framing joist from B205 was found to be splitting approximately six linear feet (**See Photo 3.6**). The 4th joist away from B207 was found to be splitting approximately six linear feet (**See Photo 3.7**) and the 9th joist was found to be splitting approximately 3 linear feet (**See Photo 3.8**). Inject cracks in joist with structural epoxy.

Photo 3.6. Exterior Deck Framing Joist from B205

Photo 3.7. Exterior Deck Framing Joist from B207

Photo 3.8. Exterior Deck Framing Joist from B207

| b. Inject joist cracks w/ structural epoxy: | \$538 |

Inject Joist Cracks w/ Structural Epoxy, B20'	6	lf	\$7.50	\$45	\$28.33	\$170	\$35.83	\$215
Inject Joist Cracks w/ Structural Epoxy, B20'	6	lf	\$7.50	\$45	\$28.33	\$170	\$35.83	\$215
Inject Joist Cracks w/ Structural Epoxy, B20'	3	lf	\$7.50	\$23	\$28.33	\$85	\$35.83	\$108

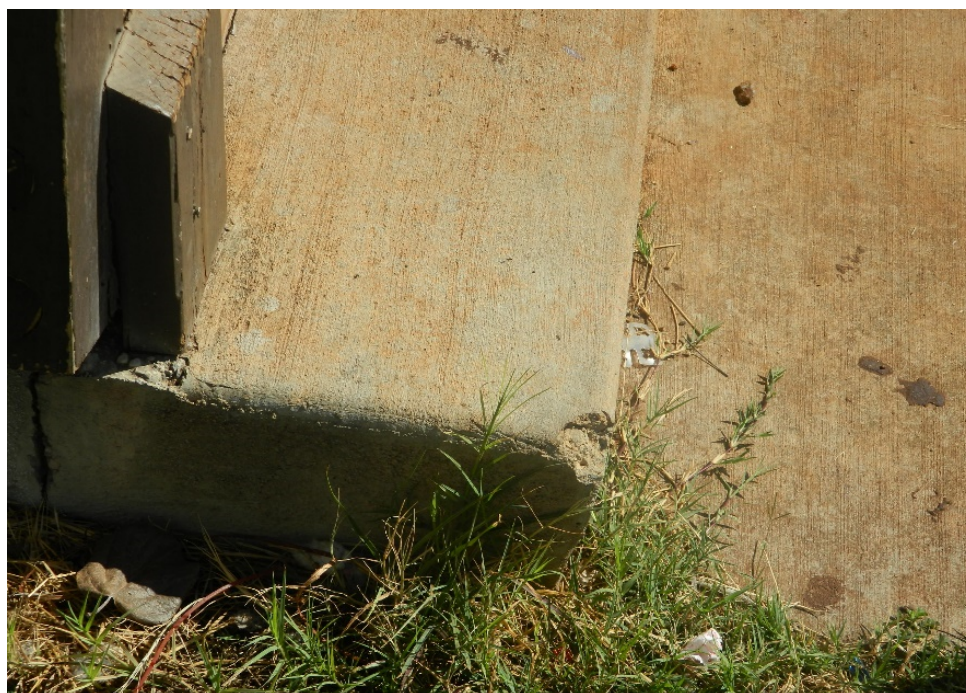
On the stair landing, there are minor spall at bottom landing corner. It does not affect the structural integrity. Recommend leaving as is (**See Photo 3.9**).

Photo 3.9. Stair Landing Corner

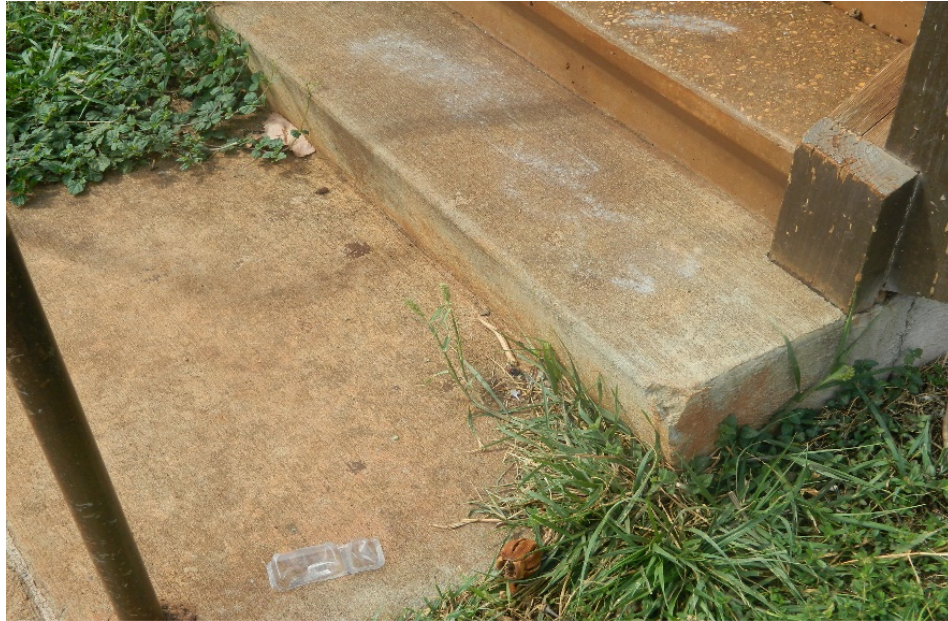
Minor spall at bottom stair landing corner. It does not affect the structural integrity. Recommend leaving as is. (**See Photo 3.10**).

Photo 3.10. Stair Landing Corner

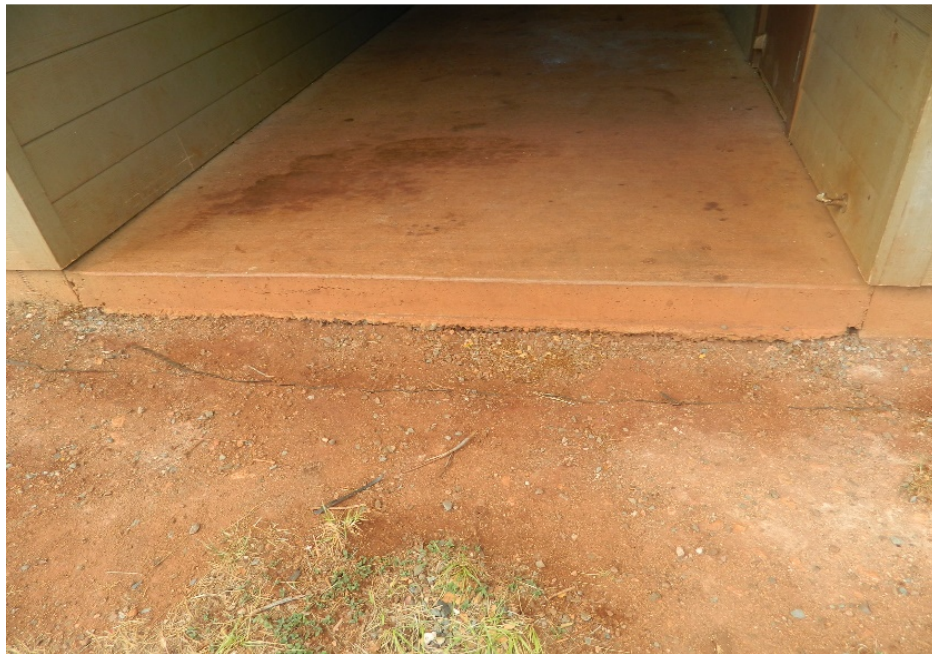
On the northeast side of the building, the bottom of the concrete slab appears to be exposed. (**See Photo 3.11**). It's recommended to add approximately 6 inches of compacted soil over a 6 feet x 8 feet area next to the building to cover the bottom of slab. The roof framing on the northeast side of building at walkway, there is a 3/4" gap between roof eave blocking and the supporting roof beam. (**See Photo 3.12**) This occurs over a distance of six feet. We recommend sealing this gap or replacing the eave blocking to prevent vermin from entering the attic space.

Photo 3.11. Exposed Slab

Add 6" Compacted Soil at Exposed Slab	0.9	cy	\$37.00	\$33	\$340.00	\$302	\$377.00	\$335
Replace Eave Blocking at Roof Beam Gap	6	lf	\$2.16	\$13	\$42.50	\$255	\$44.66	\$268

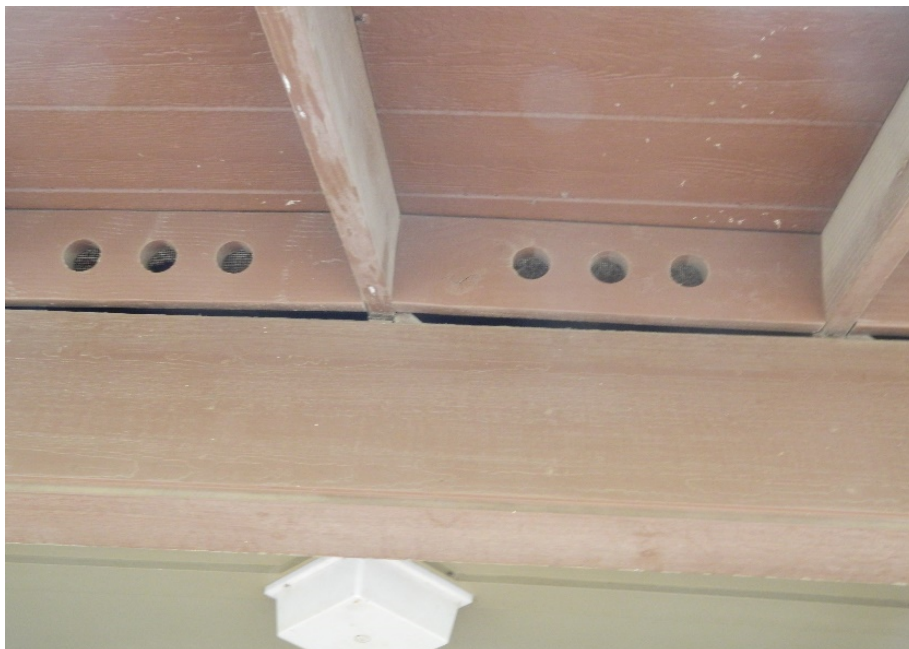
Photo 3.12. Roof Beam Gap

| d. Replace eave blocking at roof beam gap | \$268 |

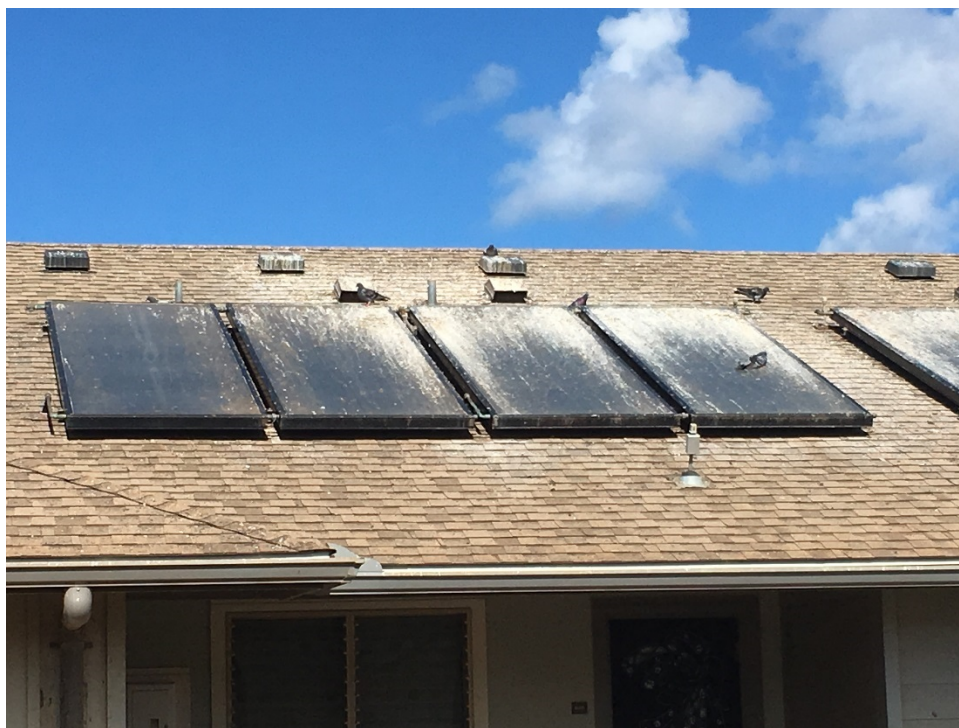
Water heating in the residential buildings is done with solar electric water heaters. The equipment is from the original construction, but there were no visible issues other than excessive bird droppings on some of the panels. Need to clean the bird droppings from panels (See Photo 4.1).

Photo 4.1. Bird Droppings on Panels
