Facility/Site: East Kapolei Pesticide Mixing/Loading Site

Subject: No Further Action with Institutional Controls for East Kapolei Pesticide
Mixing/Loading Site

REMEDIATION VERIFICATION REPORT
EAST KAPOLEI II PESTICIDE MIXING AND LOADING SITE
TMK (1) 9-1-017: Parcel 110 (Portion)
Ewa, Oahu, Hawaii

Project No. 09-2012

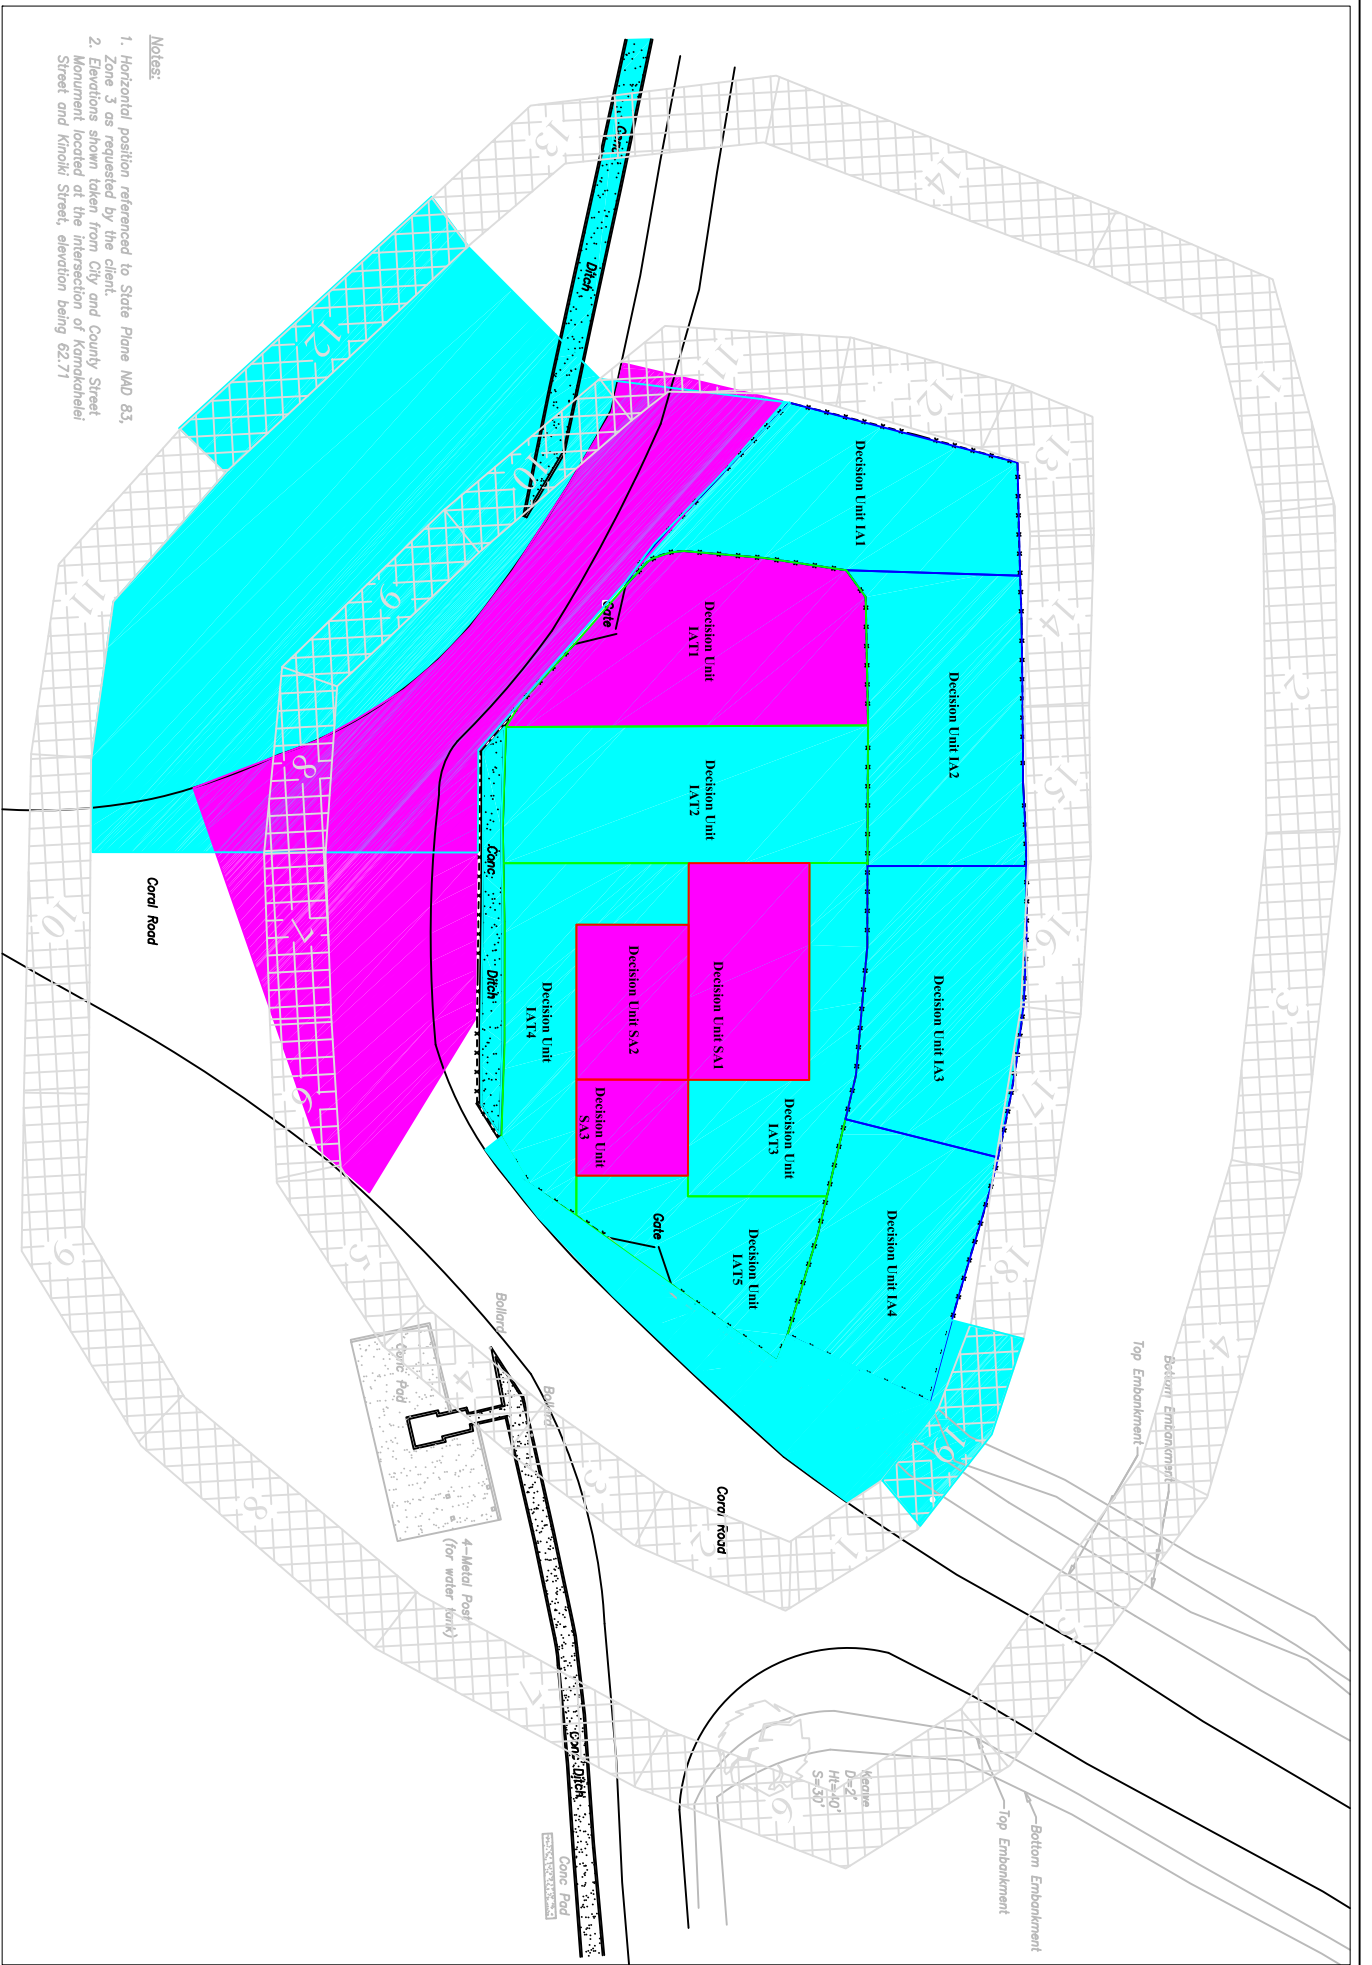
Figure 7 - Direct Exposure Hazards
 Remediation Verification Report
 East Kapolei II PML Site
 Ewa, Oahu, Hawaii

A summary of the existing environmental hazards within the East Kapolei PML site is presented by decision unit in Table 3 below. These environmental hazards, as well as hazards outside of the East Kapolei PML site fence line, are shown in Appendix I, Figures 7 and 8.

Outside of the East Kapolei PML site fence line, direct exposure and terrestrial ecotoxicity hazards associated with elevated arsenic concentrations were identified in surface and near surface soil south and southwest of the PML, generally adjacent to the southwest gate and within the coral/dirt road intersection. Furthermore, direct exposure hazards associated with elevated dioxins/furans TEQ concentrations were identified in surface soil southwest of the site out to the second decision unit ring (and including DU12 of the second decision unit ring) identified in the August 2007 *Final Site Investigation and Preliminary Remedial Alternatives Analysis* report and within portions of the concrete-lined irrigation ditch adjacent to and southwest of the PML site. The estimated extent of direct exposure hazards and leaching to groundwater hazards are presented in Appendix I, Figures 7 and 8.

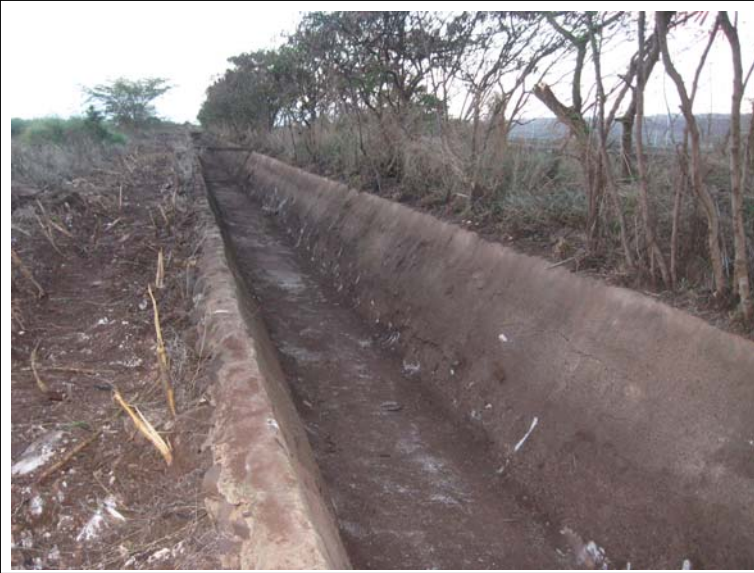
Photograph 4: Soil from concrete-lined irrigation ditch removed and placed within PML site. No breaks in concrete-lined ditch observed.

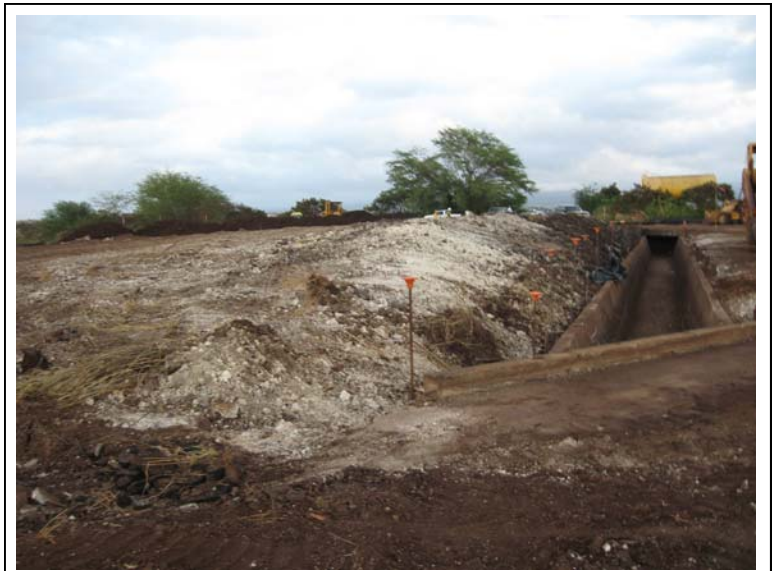
Photograph 5: Soil removed from section of concrete-lined irrigation ditch adjacent to PML site.

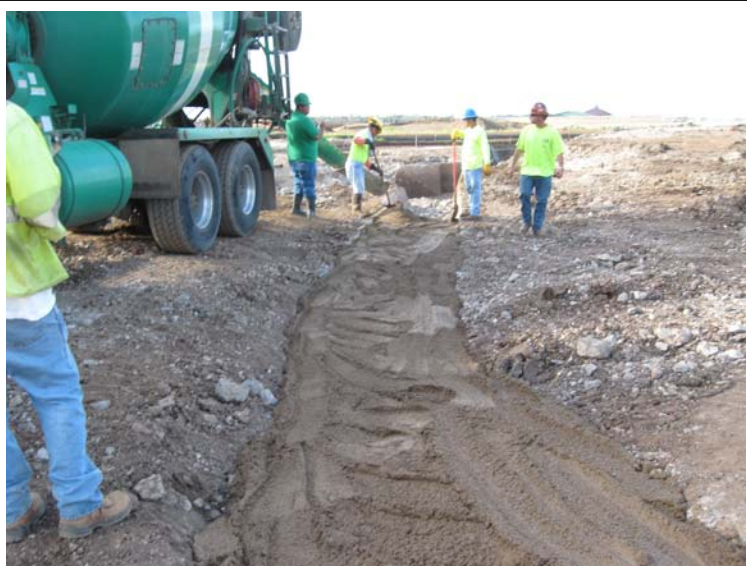
Photograph 7: CLSM used to fill irrigation ditch after demolition of concrete culverts beneath haul roads.

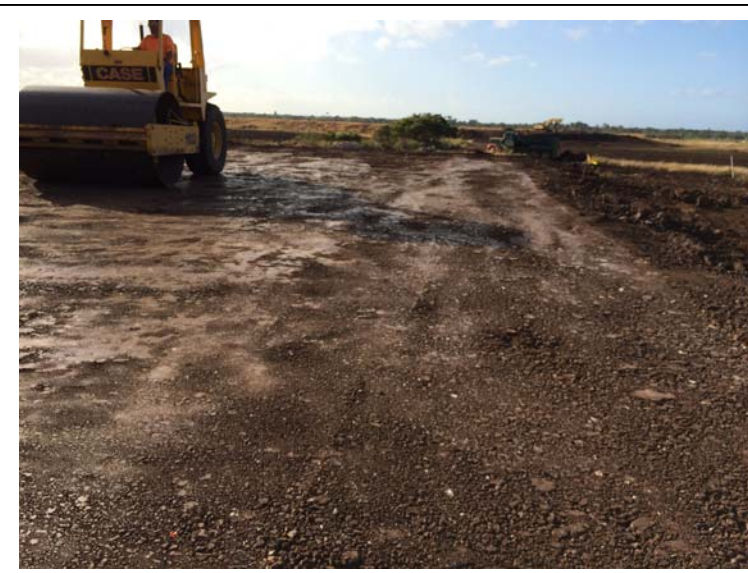
Photograph 12: Compacting low permeability soil prior to placement of geotextile fabric and geomembrane liner.

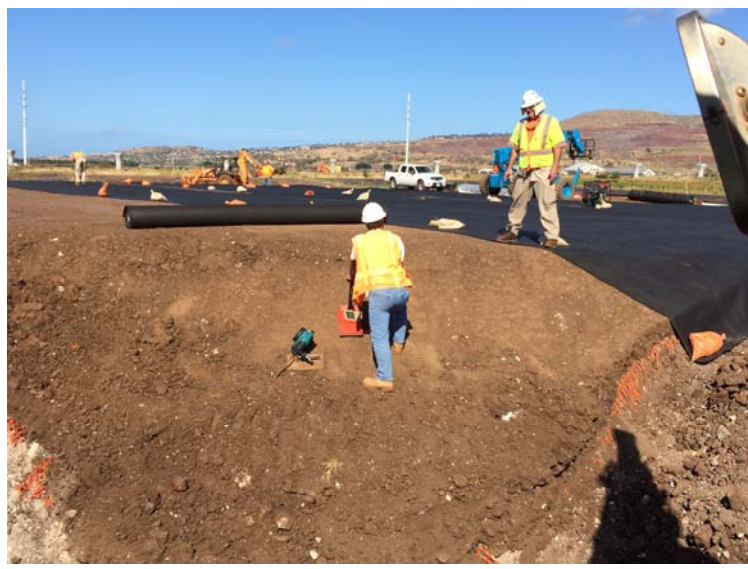
Photograph 13: Hirata & Associates checking soil compaction prior to placement of fabric and liner.

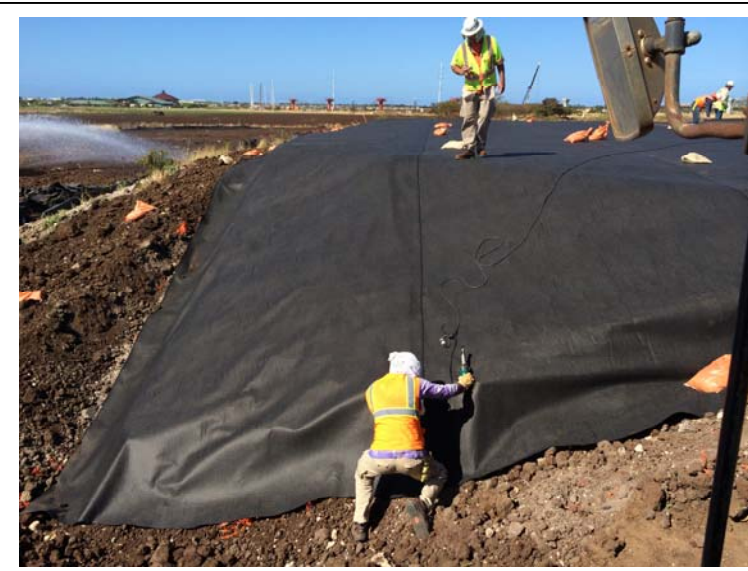
Photograph 15: Welding and securing geomembrane liner.

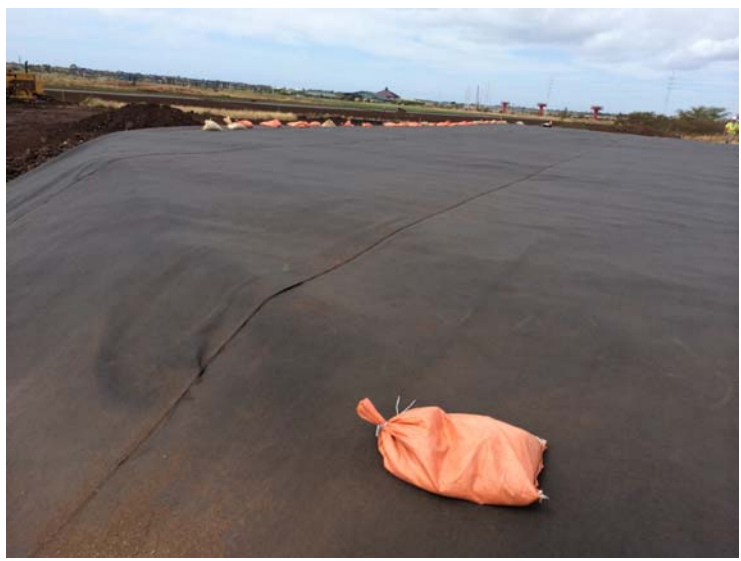
Photograph 16: View of geomembrane liner, welded and anchored in placed.

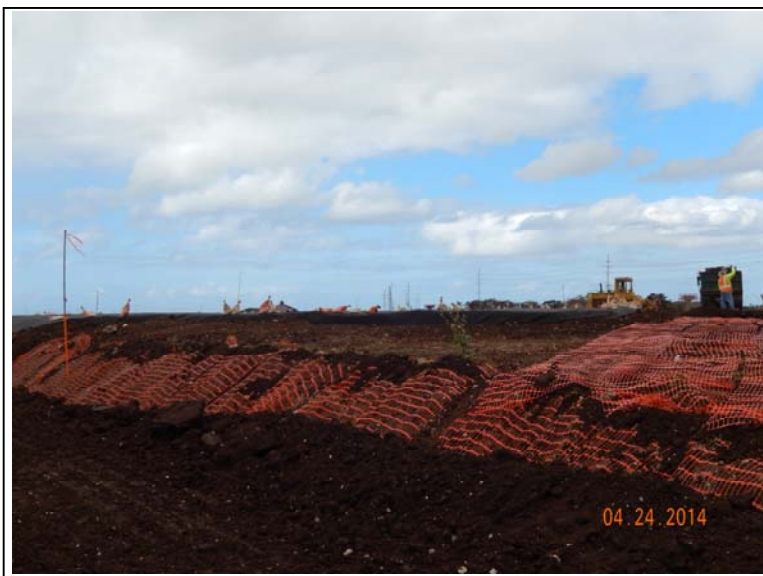
Photograph 21: Orange construction fence used as visual indicator barrier.

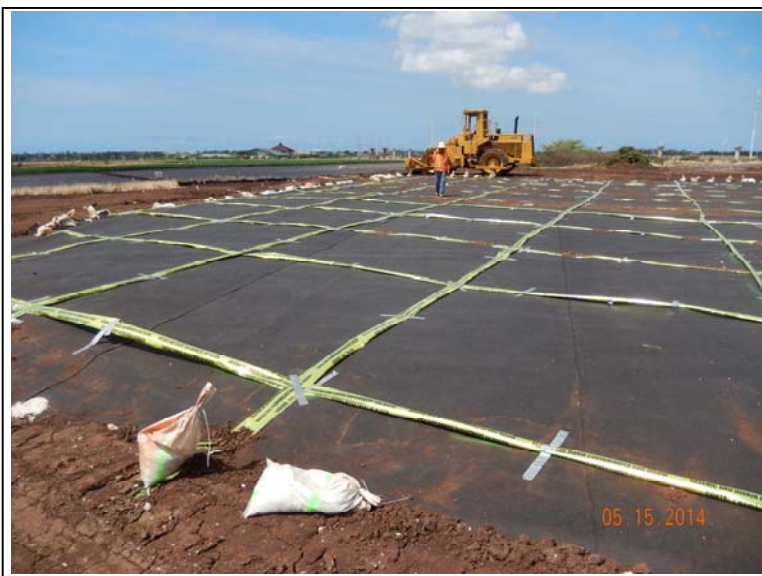
Photograph 24: Placement of metallic tape using 10-foot grid spacing.

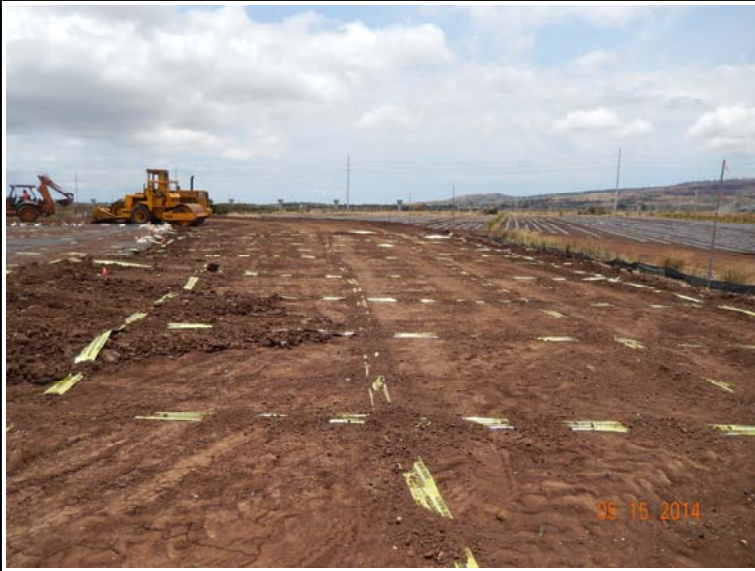
Photograph 25: View of metallic tape placed above contaminated soil (thin layer of soil between orange construction fencing and metallic tape).

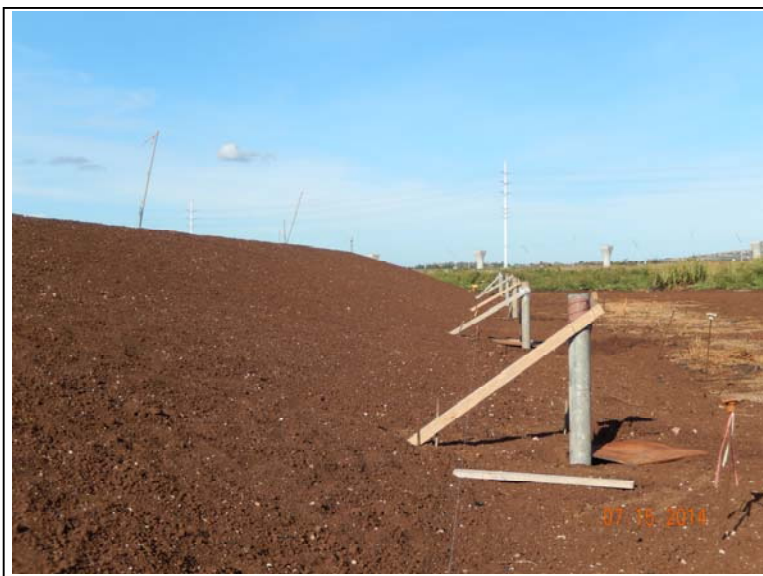
Photograph 30: View of pipe bollards prior to filling with concrete, installed along the perimeter of the capped area.

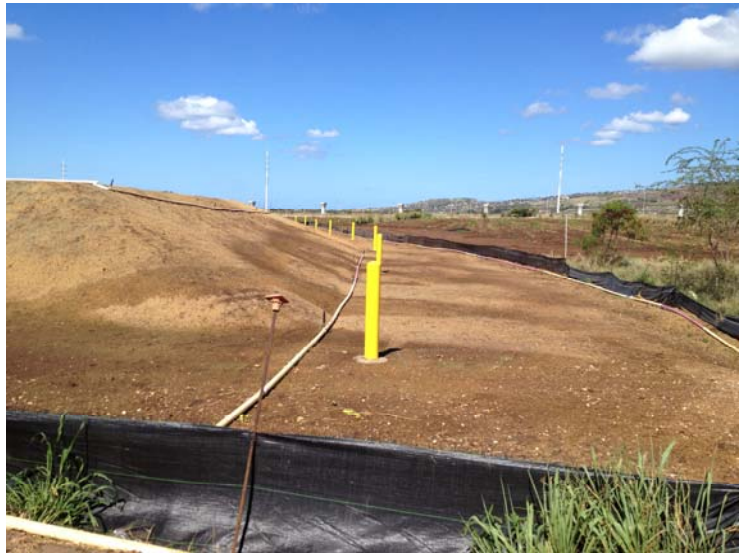
Photograph 31: View of concrete-filled pipe bollards. Hydroseeding complete, irrigation system installed.
