Site and Facility Assessment For Ulu Ke Kukui Transitional Housing

Wai'anae, O'ahu, Hawai'i
87-576 Kula'aupuni Street
TMK: (1) 8-7-010:030

October 31, 2017 (FINAL)

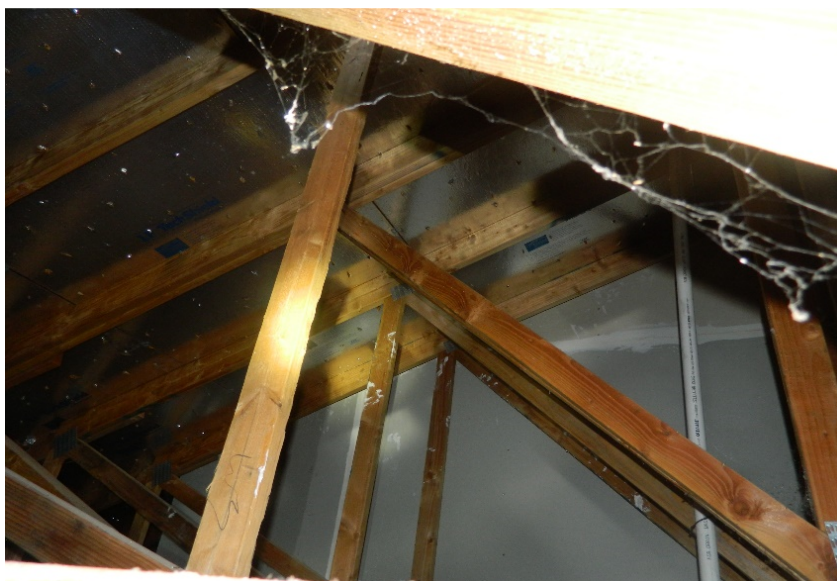
Photo 3.1. Attic

The existing structures are two-story timber framed with a sloped roof with roof eaves. In the attic space, the roof is framed primarily with 2x wood trusses spaced at 24" on center. The 2x wood rafters at the ends of the building extend over the top chord of the step-down trusses (**See Photo 3.1**). The interior roof sheathing uses LP techshield which has a foil coating on the interior surface. The exterior roof sheathing at the eaves appear to be T1-11 plywood which have the grooves facing downward. The exterior wall sheathing is a combination of what appears to be horizontal siding at some areas and board and batten at other areas.

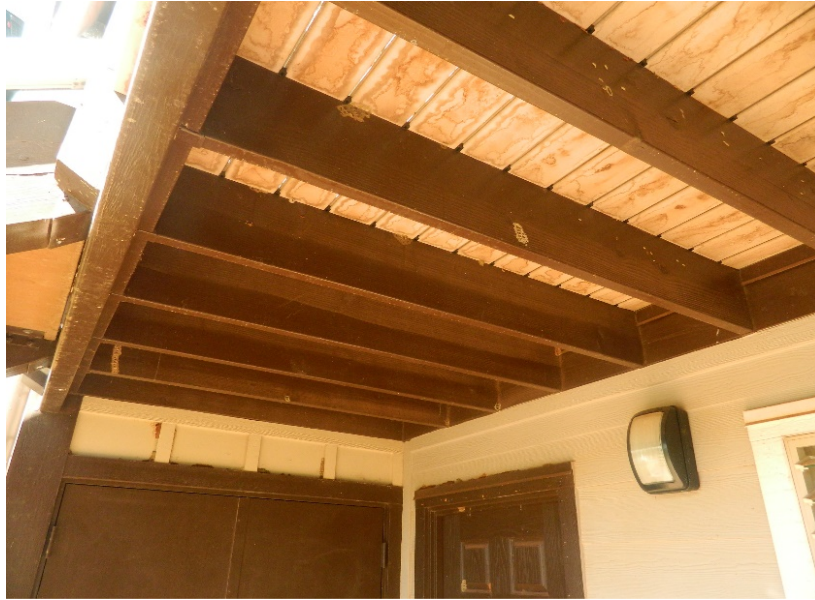
Photo 3.2. Second Floor Joist

The buildings most likely have 2x4 framed stud walls that serve as both bearing and shear walls. The floor joist was not observed but the floor system is most likely framed with 2x floor joists. The second-floor common entry area is framed with 1x spaced TREX decking over 2x joists spaced at 16" on center (**See Photo 3.2**). There are second floor joists at the entry area and the exterior slab edges. The rest of the structural framing was not visible. Each building has an outdoor laundry area on each side which is framed with 2x wood roof rafters spaced at 24" on center and supported by a wood beam and steel pipe columns.
