Facility/Site: East Kapolei Pesticide Mixing/Loading Site

Subject: No Further Action with Institutional Controls for East Kapolei Pesticide
Mixing/Loading Site

REMEDIATION VERIFICATION REPORT
EAST KAPOLEI II PESTICIDE MIXING AND LOADING SITE
TMK (1) 9-1-017: Parcel 110 (Portion)
Ewa, Oahu, Hawaii

Project No. 09-2012

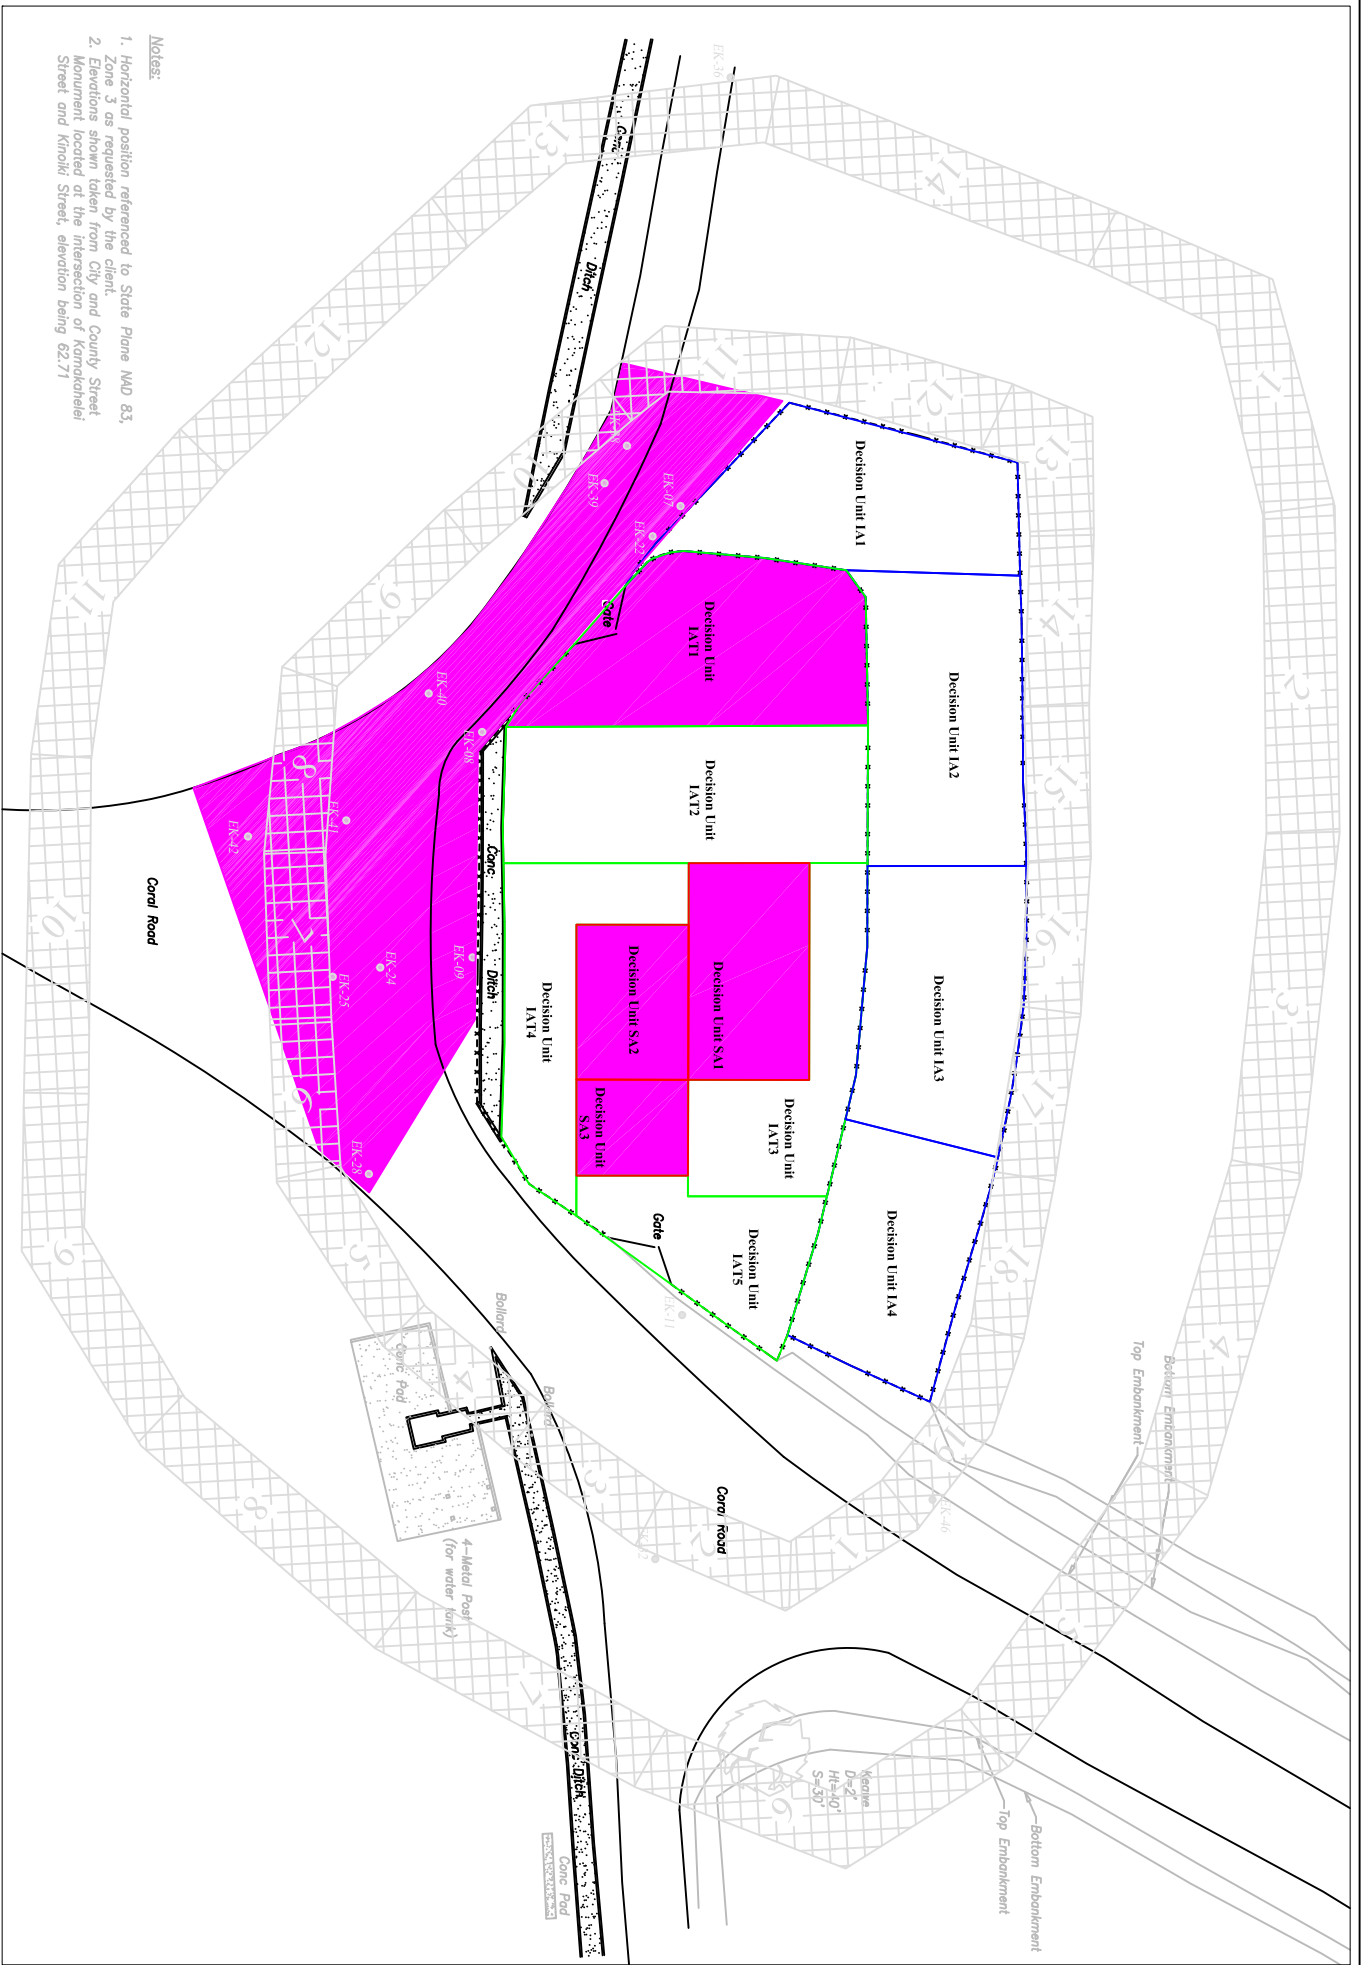
Figure 4 - Extent of Arsenic Impacts
 Remediation Verification Report
 East Kapolei II PML Site
 Ewa, Oahu, Hawaii

Based on review of current and historic data, the extent of COC impacts to soils at concentrations exceeding default DOH EALs within and adjacent to the East Kapolei PML site is shown in Figures 4 through 8 in Appendix I.

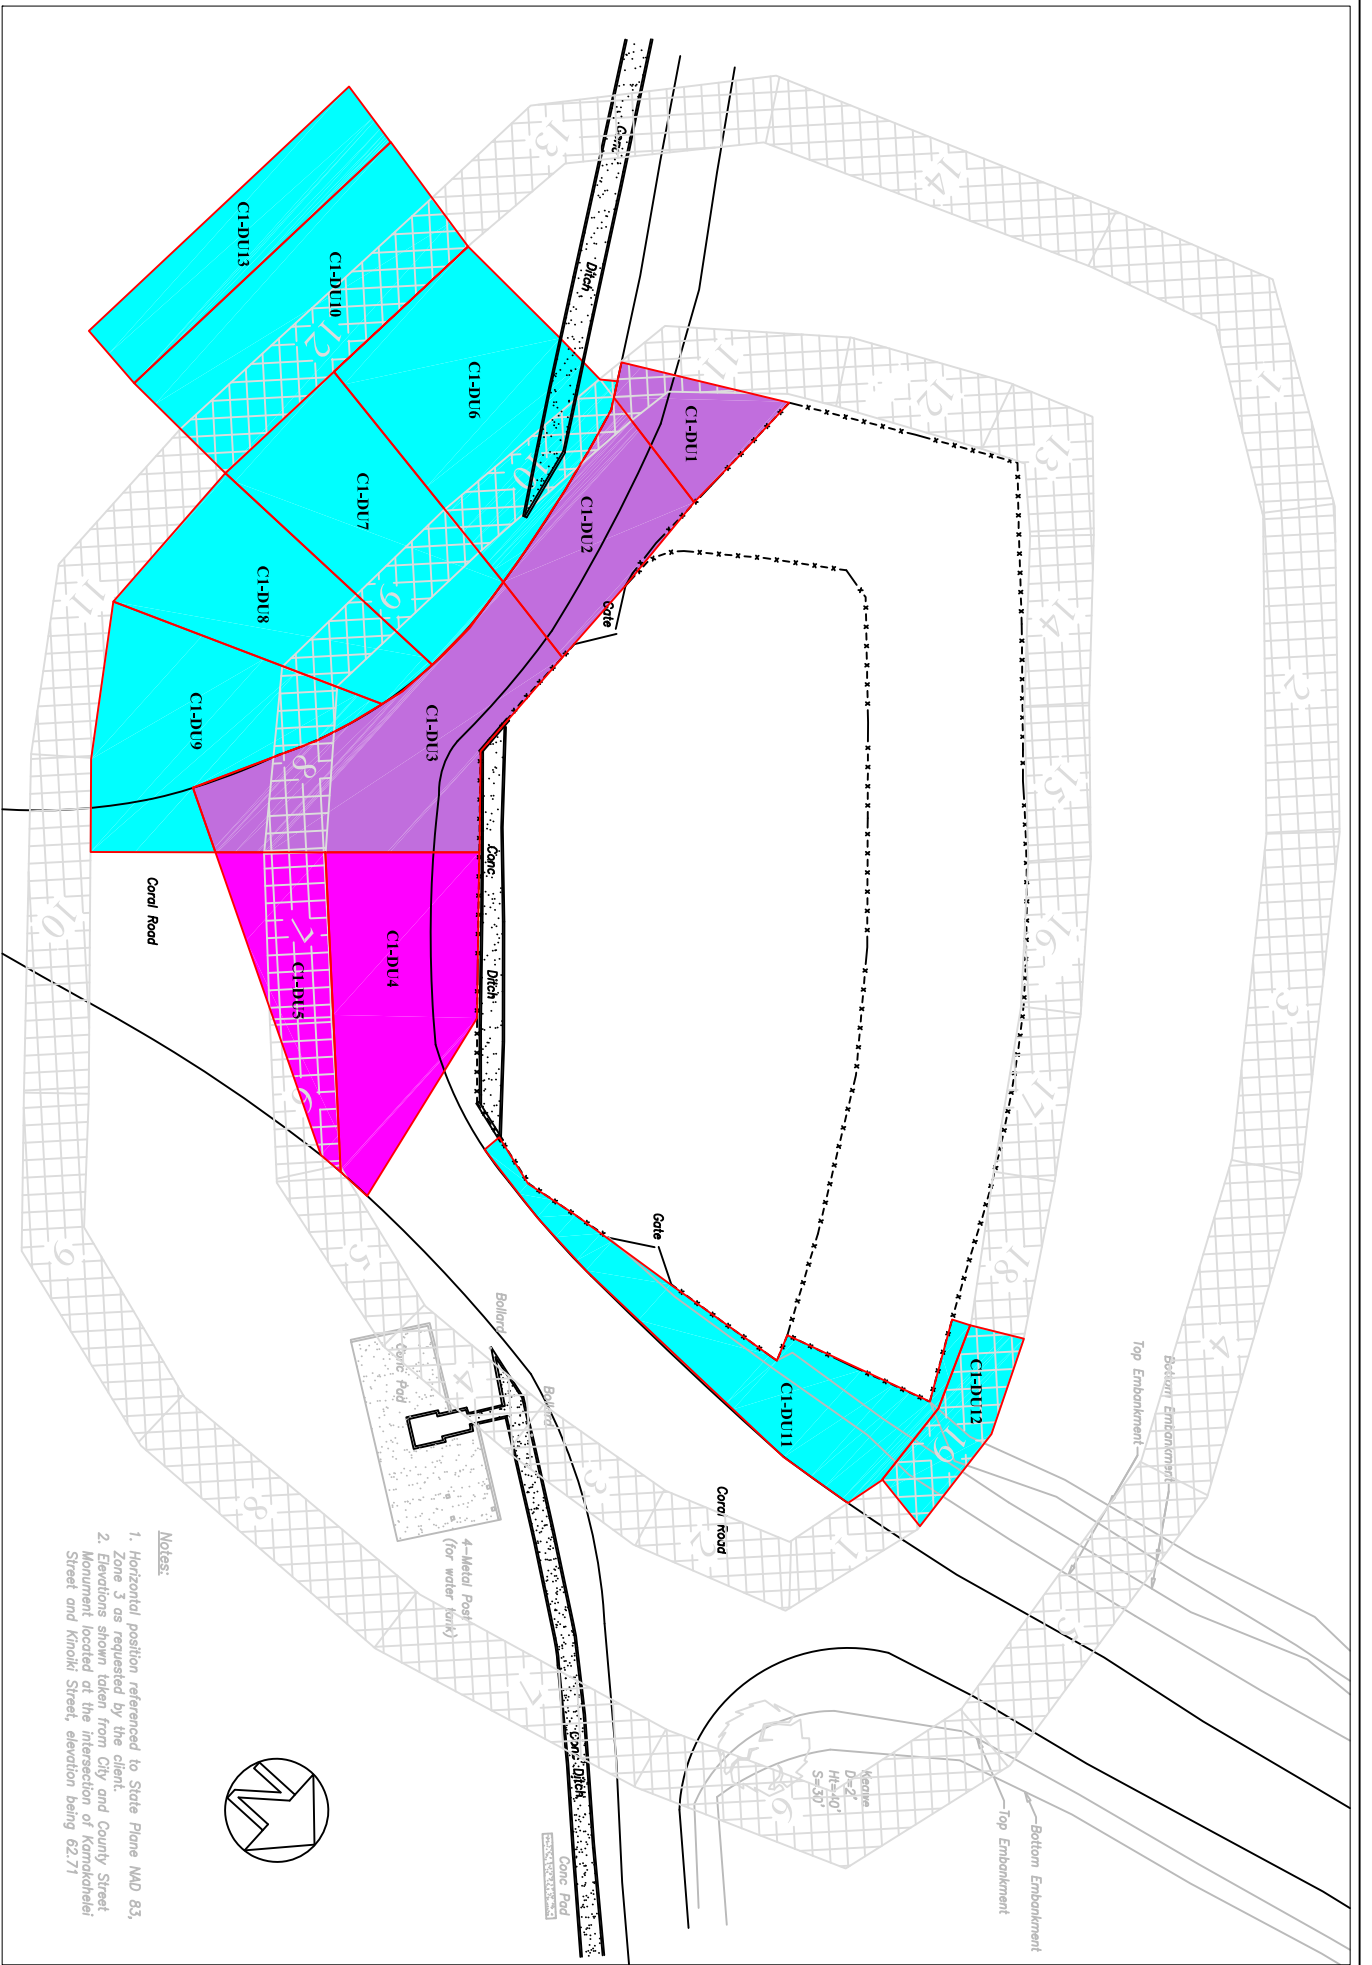
Figure 11
Initial Confirmation Sample DUs
Remediation Verification Report
East Kapolei II PML Site
Ewa, Oahu, Hawaii

Confirmation soil sample collection was initially planned for areas outside of the East Kapolei PML site boundaries following excavation and relocation of impacted soils. A total of thirteen decision units were initially established within the excavated areas based on data from previous investigations. Flags were used to indicate physical boundaries in areas where boundaries were not readily evident (i.e., no excavation “wall” to indicate decision unit boundary). These initial decision units are shown in Appendix I, Figure 11.
