ADDENDUM NO. 2

PAPAKOLEA SUBDIVISION SEWER IMPROVEMENTS
AUWAIOLIMU SLOPE STABILIZATION AND SEWER LINES C & C-1 IMPROVEMENTS

PAPAKOLEA, OAHU, HAWAII

IFB-17-HHL-011

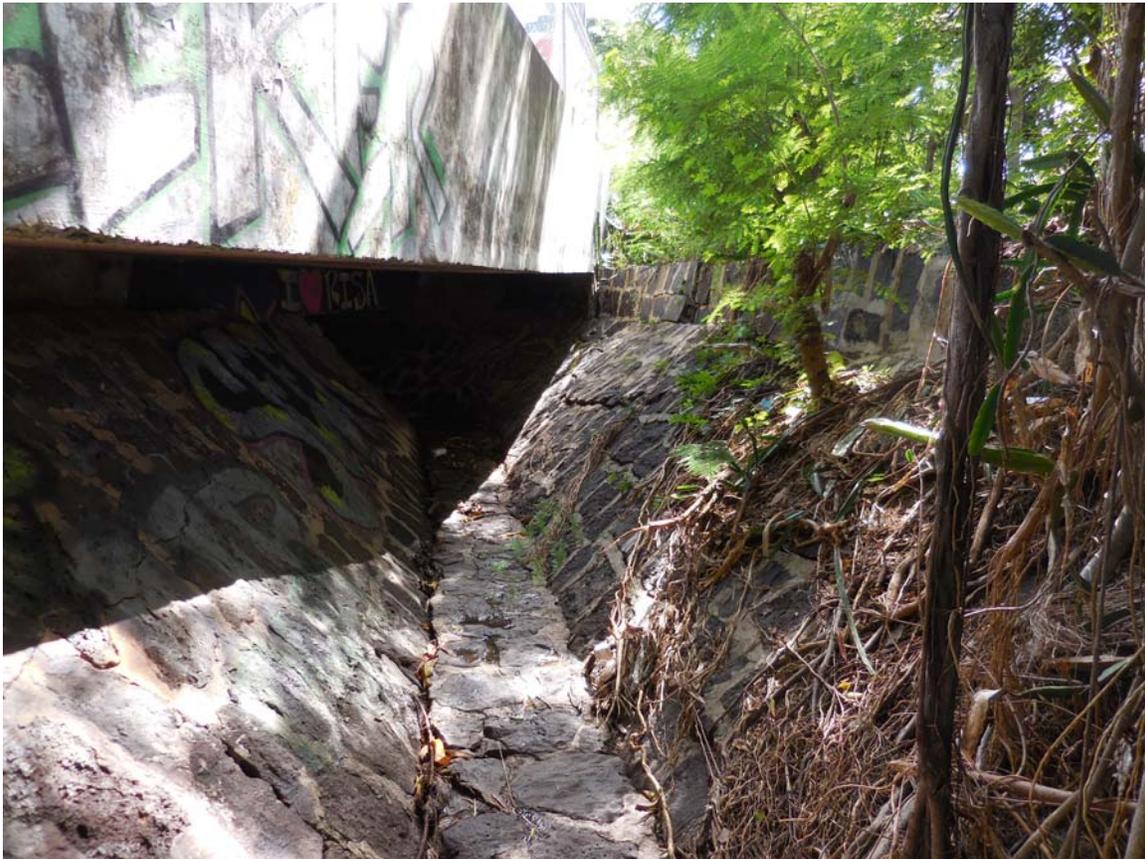
A site visit was made to observe: 1) the existing ditch distress condition adjacent to Hiilani Street and 2) the existing condition of the embankment at the far eastern end of the site proposed for Erosion Control Mat (ECM) installation.

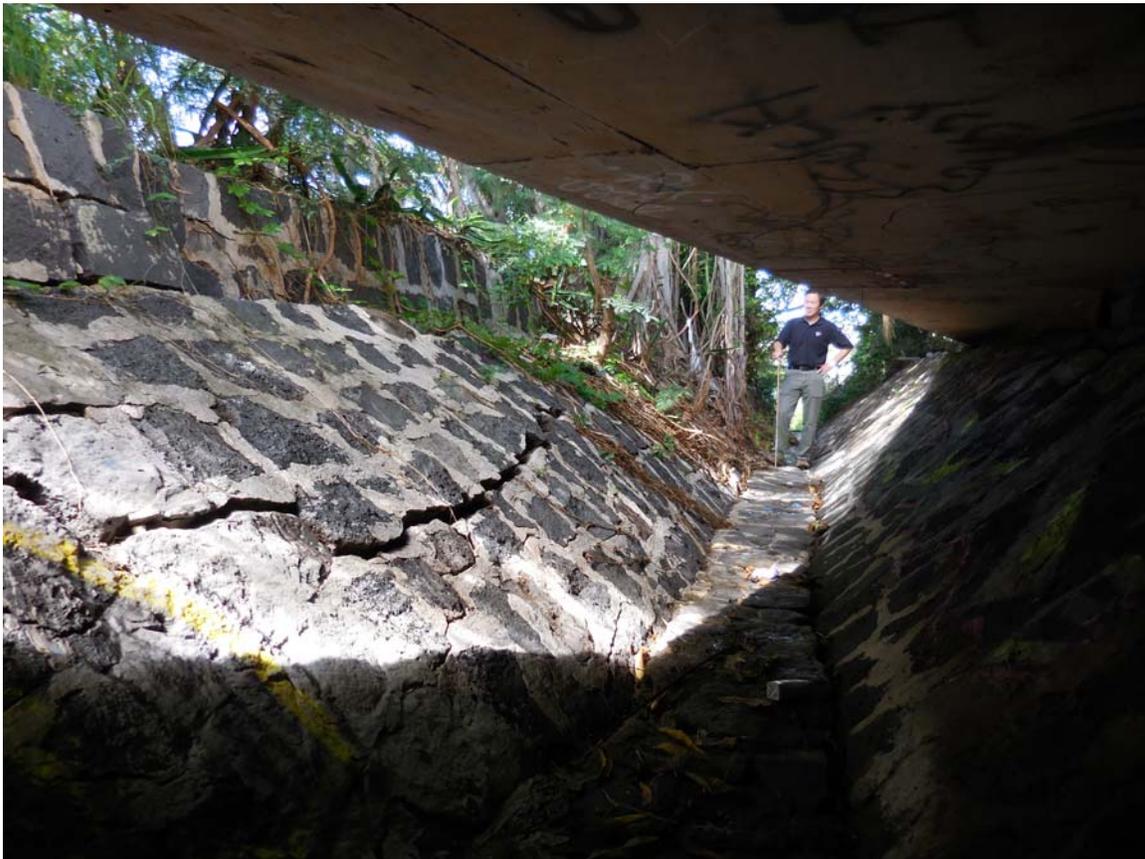
Based on our observations, the existing trapezoid ditch constructed of Grouted Rubble Pavement (GRP) has experienced cracking and offset distress believed to be a result of adjacent top-of-slope ground instability. The trapezoidal ditch has a 2-foot wide

floor and 4-foot high side slopes. An additional height of wall (2-foot) forms an extended splash containment wall along the top edge on the slope-side of the ditch. The length of ditch distress is approximately 25 linear feet spanning from a culvert discharge point to a large banyan tree trunk bounding the slope-side of the ditch, as shown in the photograph below.

Considering limited space between edge of the slope and roadway, construction of the micropile will be challenge, especially some of the areas are partially under the roadway cantilever structure. Based on our observation, we believe the cracked GRP lining may be removed and 2-foot splash containment wall may be reinstalled with a minimum of 12 inches off-set away from the slope edge. This may result in a relative small reduction on cross section area of the trapezoidal ditch, however, it should still be larger than the cross section area of the ditch inlet.

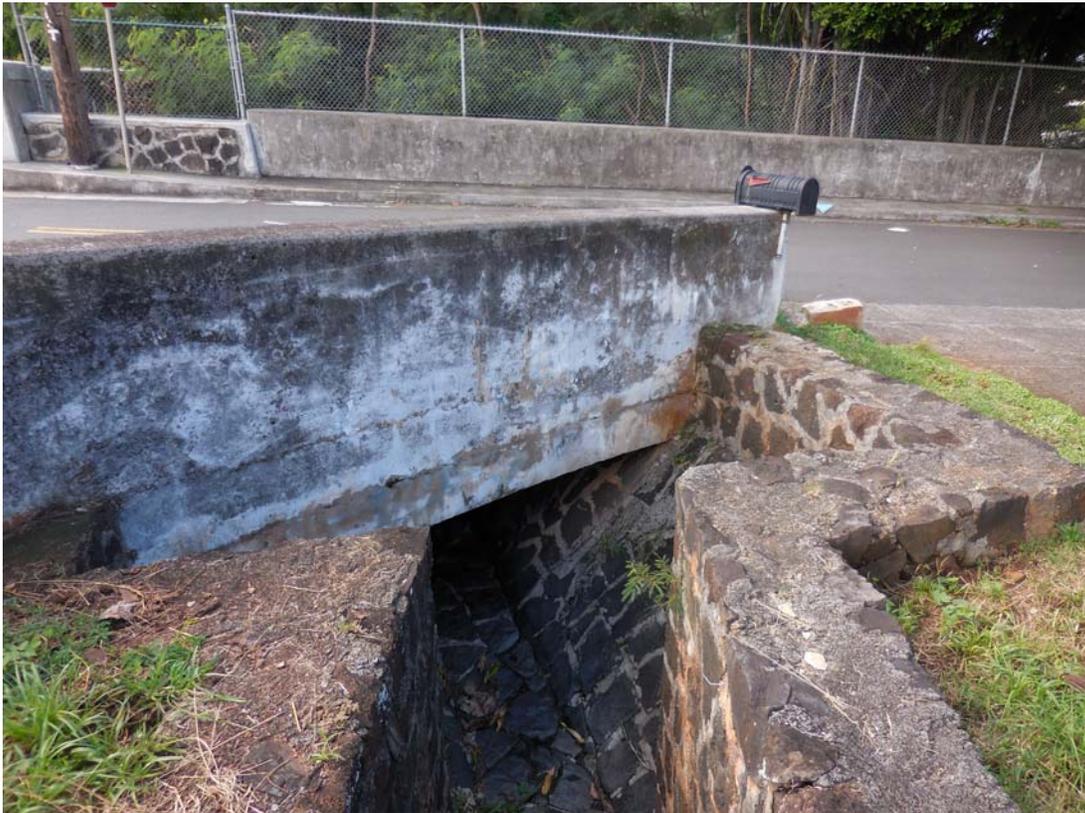
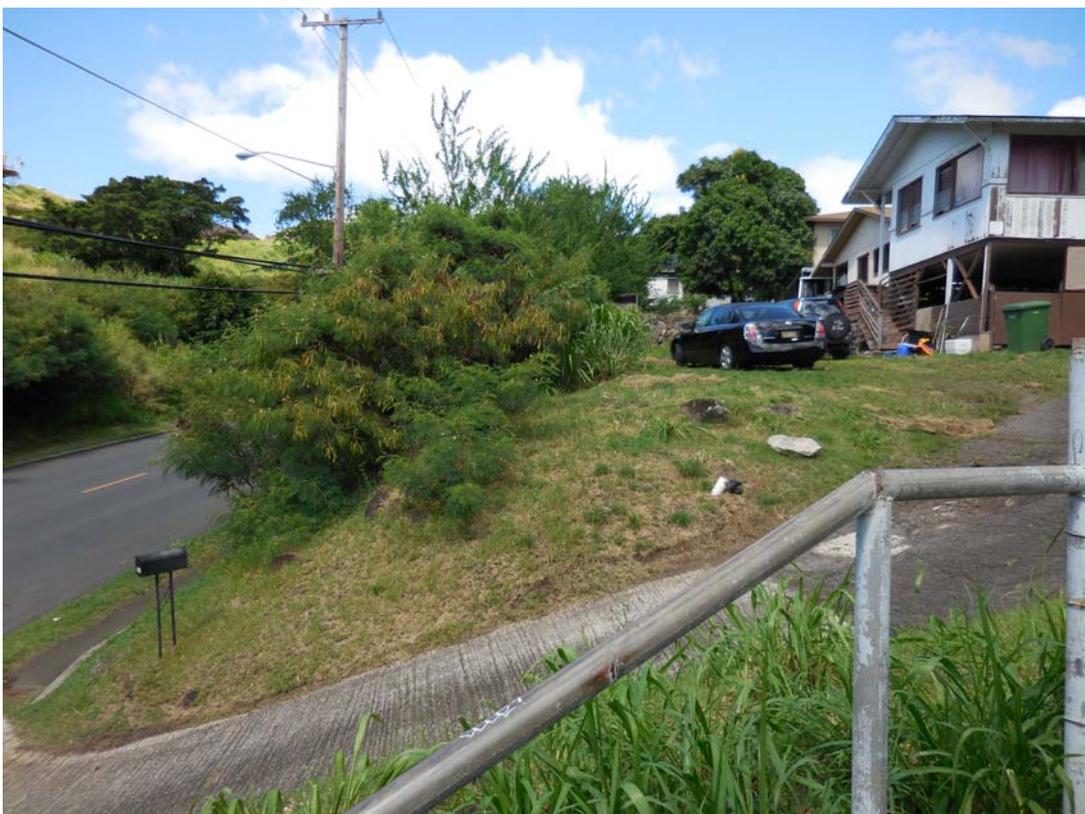
Based on our observations, the approximate 120-foot long segment of slope at the far southern end of the slope stabilization project site stands at about 1.5H:1V. The slope height appears to be about 8 to 12 feet in height and composed of mixed soil with embedded rocks (cobbles and boulders). Based on our observations, the upper half to 1/3 of the slope height contains assorted loose, dry-stacked boulders that form a top of slope retention features for the back yards of Parcels 027 and 028. Excavation for the 6-inch sewer line replacement along the top of slope may destabilize the rocky deposits and create a condition where additional slope stabilization effort may be required.

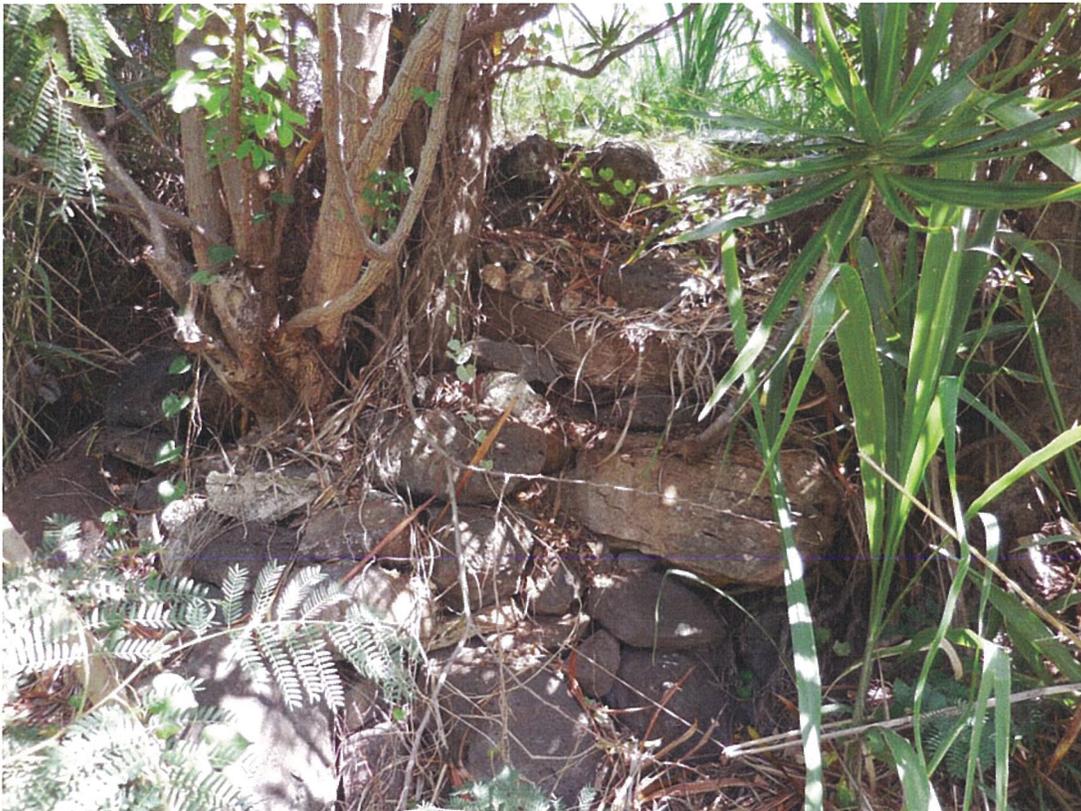
Based on exposed soil predominated slope at the site, we believe that installation of the erosion control matting is feasible, provided the dry-stacked boulder wall should be completely removed for slope restoration with 2H:1V inclination. For the public safety, chain link fence may be prudent to install at top of the slope along the right-of-way boundary.

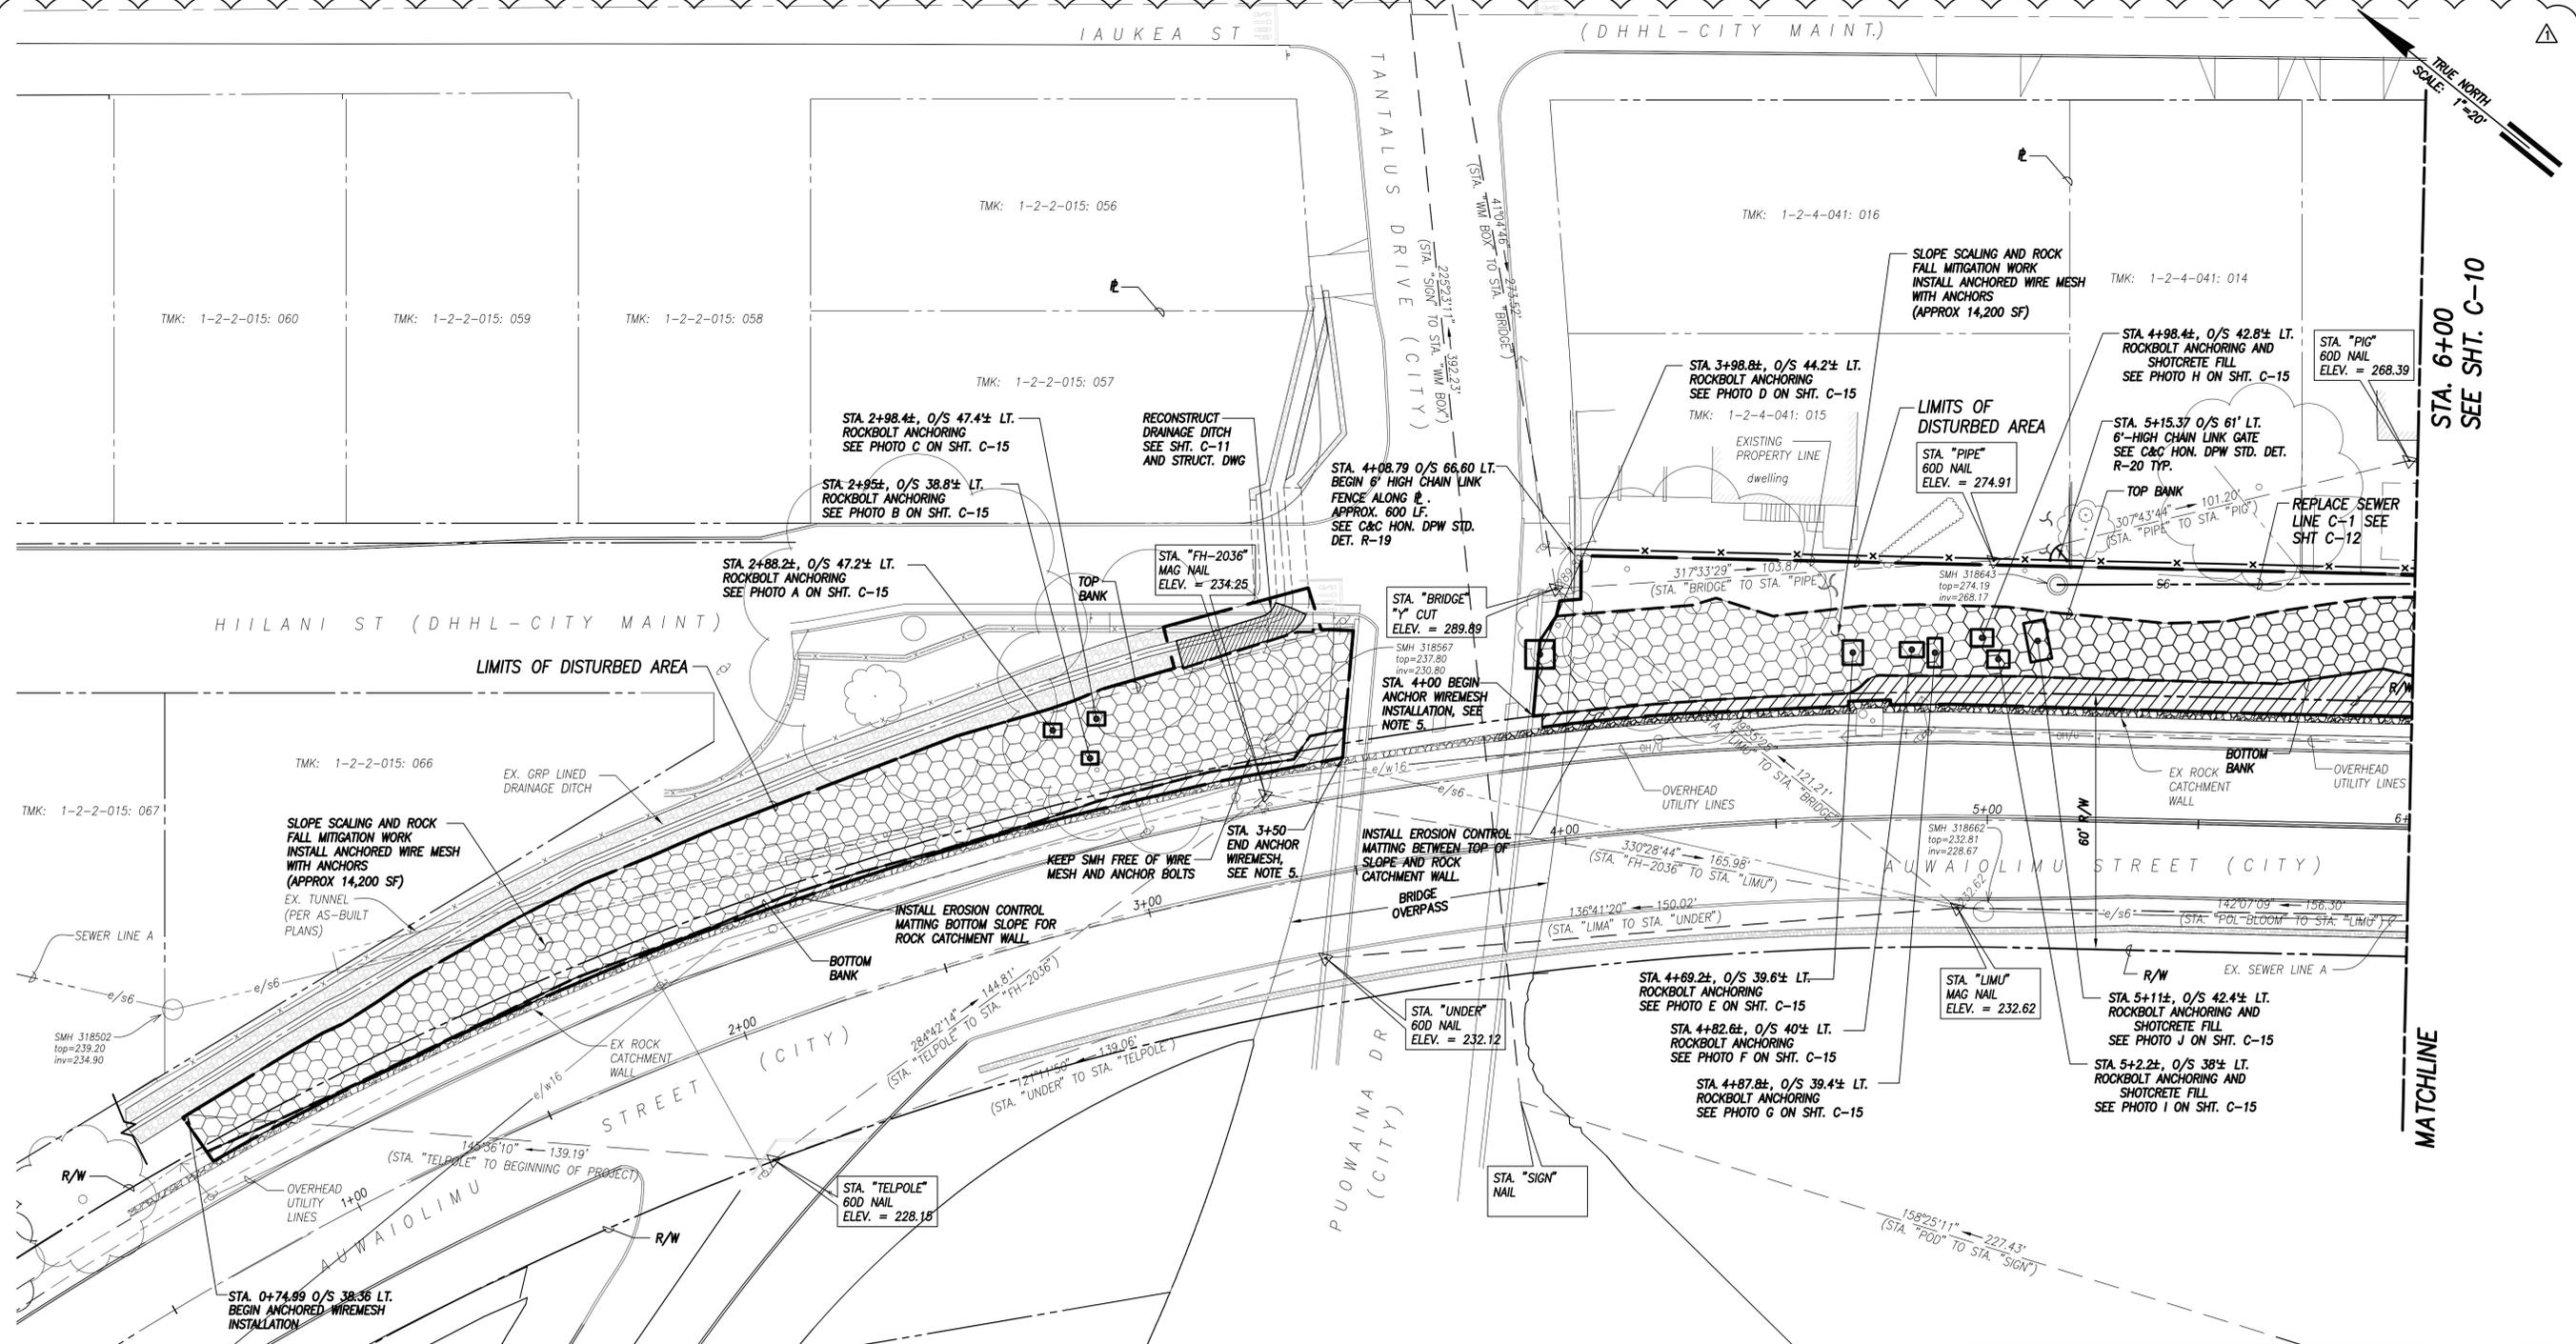
SITE PLAN - 1
SCALE: 1" = 20'

- NOTES:**
- CONTRACTOR SHALL EXERCISE CAUTION WHEN WORKING AROUND EXISTING ELECTRICAL OVERHEAD LINES.
 - AFTER CLEARING, ADDITIONAL BOULDERS MAY REQUIRE BOLTING AS DIRECTED BY THE GEOTECHNICAL ENGINEER.
 - CONTRACTOR SHALL EXERCISE CAUTION WHEN WORKING NEAR EXISTING SEWER LINES. IT IS THE CONTRACTOR'S RESPONSIBILITY TO PREVENT DAMAGE TO EXISTING SEWER LINES.
 - PRIOR TO INSTALLATION OF ANCHORS, CONTRACTOR SHALL CONDUCT A GEOPHYSICAL SURVEY TO EXISTING SEWER TUNNEL ALIGNMENT. SURVEY DATA SHALL BE SUBMITTED TO THE ENGINEER FOR REVIEW AND EVALUATION. THE ANCHORS ADJACENT TO THE TUNNEL MAY BE RELOCATED TO PREVENT DAMAGE TO EXISTING SEWER LINES AND TO REDUCE GROUT LOSS IN THE TUNNEL.
 - ANCHOR WIREMESH SHALL BE INSTALLED UP TO THE SHOTCRETE SURFACE UNDER THE PUOWAINA DRIVE BRIDGE OVERPASS.

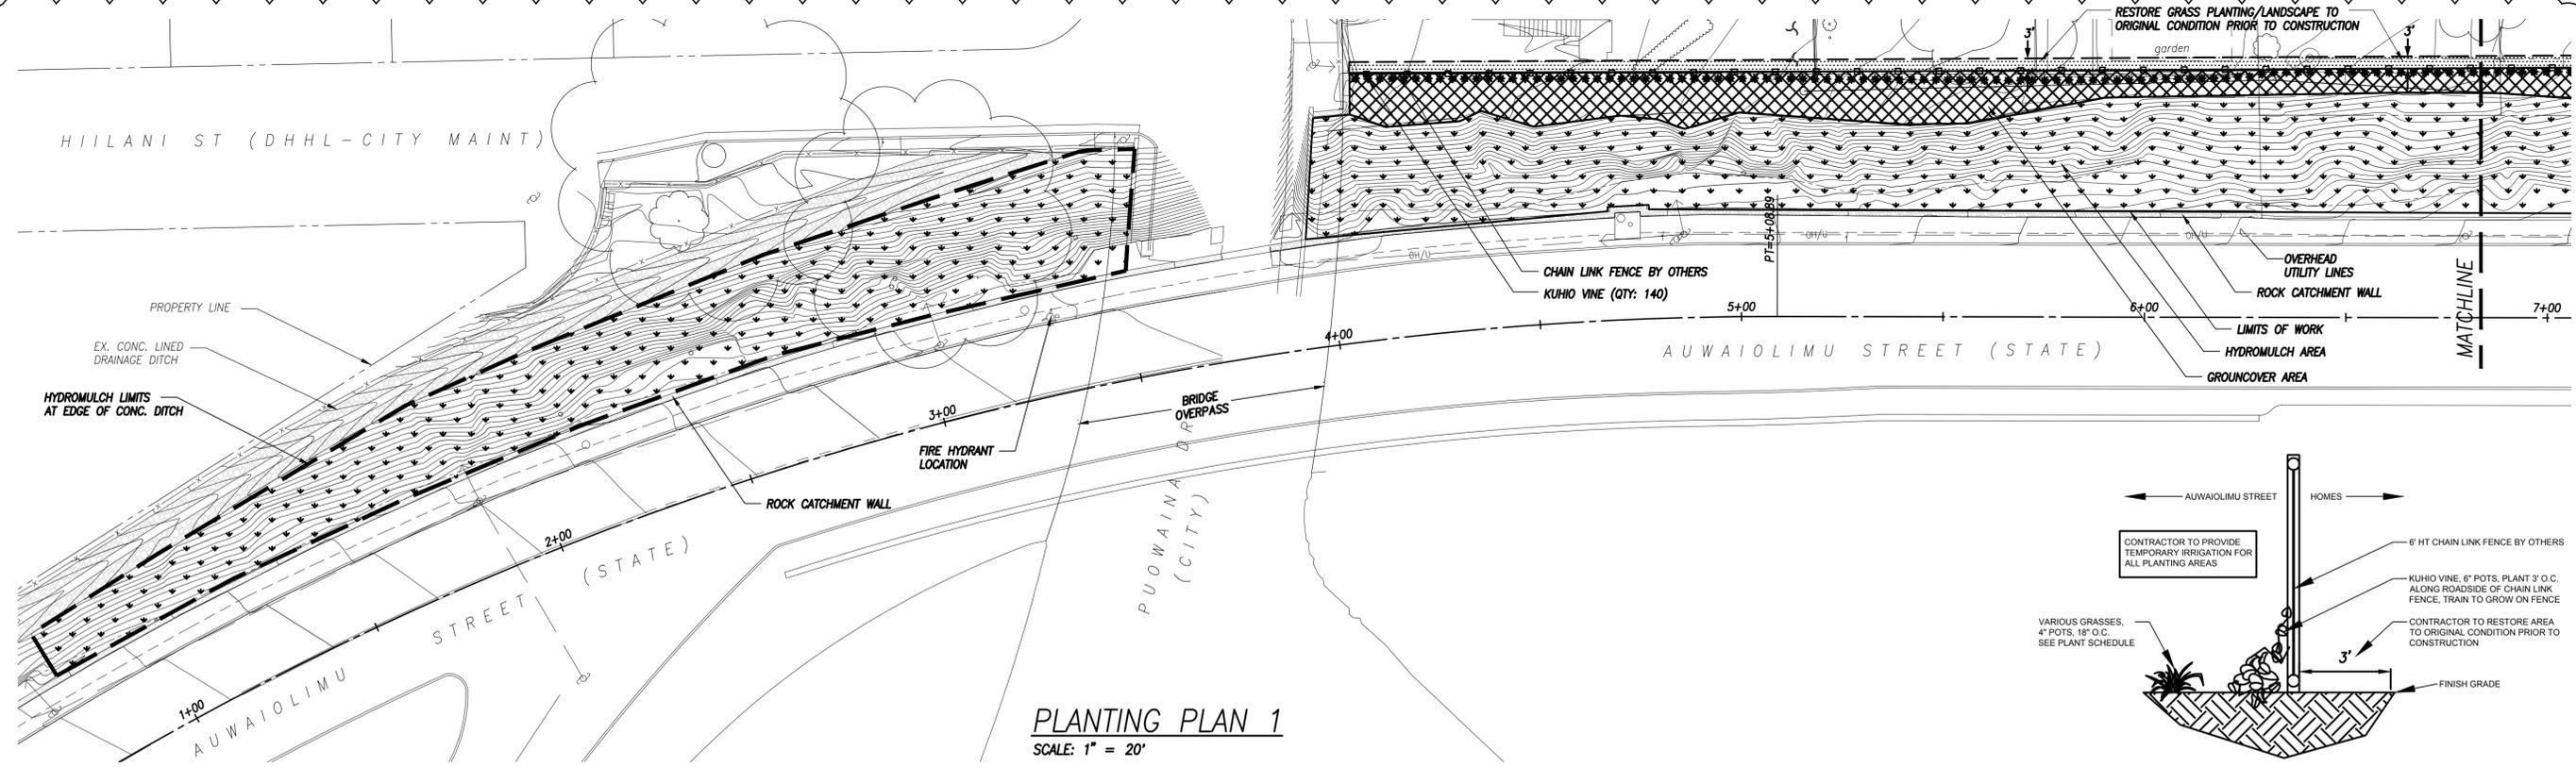
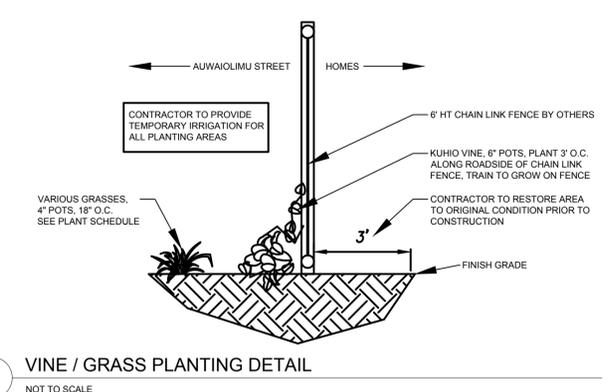
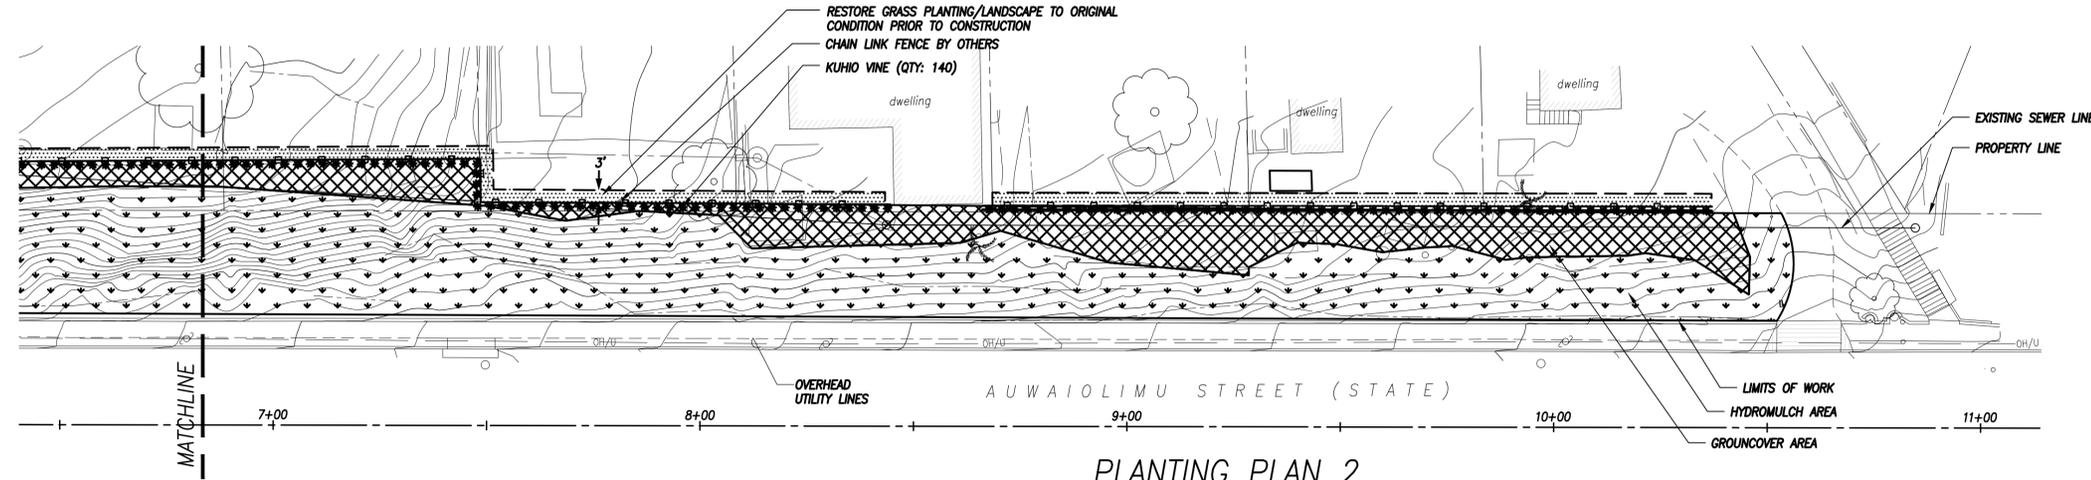
REVISION	DATE	BRIEF	BY	APPROVED
△	3/27/17	ADD 2: Rmv trees; extend vines	LI	DHHL
