# MALAMA CULTURAL PARK

## SPECIAL AREA PLAN

DRAFT: April 2022

DEPARTMENT OF HAWAIIAN HOME LANDS

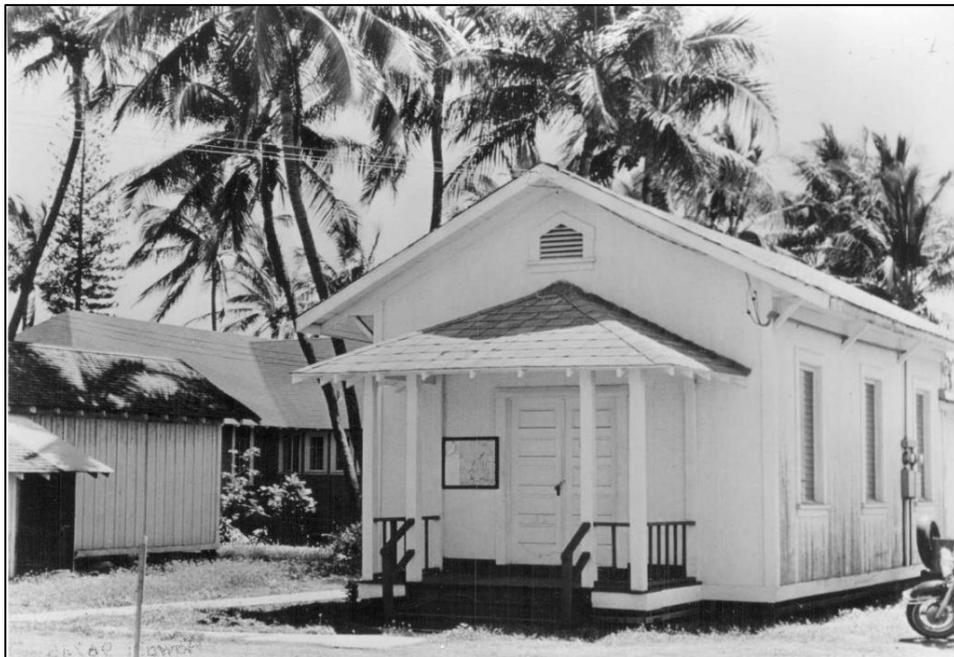
**FIGURE 3-23 HISTORIC JAILHOUSE BEFORE MOVED TO MALAMA CULTURAL PARK**

Since the structure has been moved from its original location and is in very poor condition, it is ineligible for inclusion on the National Register of Historic Places. It was evaluated in 2015 by the National Park Service due to its association with the Japanese internment camps in Hawai‘i during WWII but was considered to have “no integrity remaining.” Currently, the jailhouse is in poor condition with a collapsed roof and missing walls.

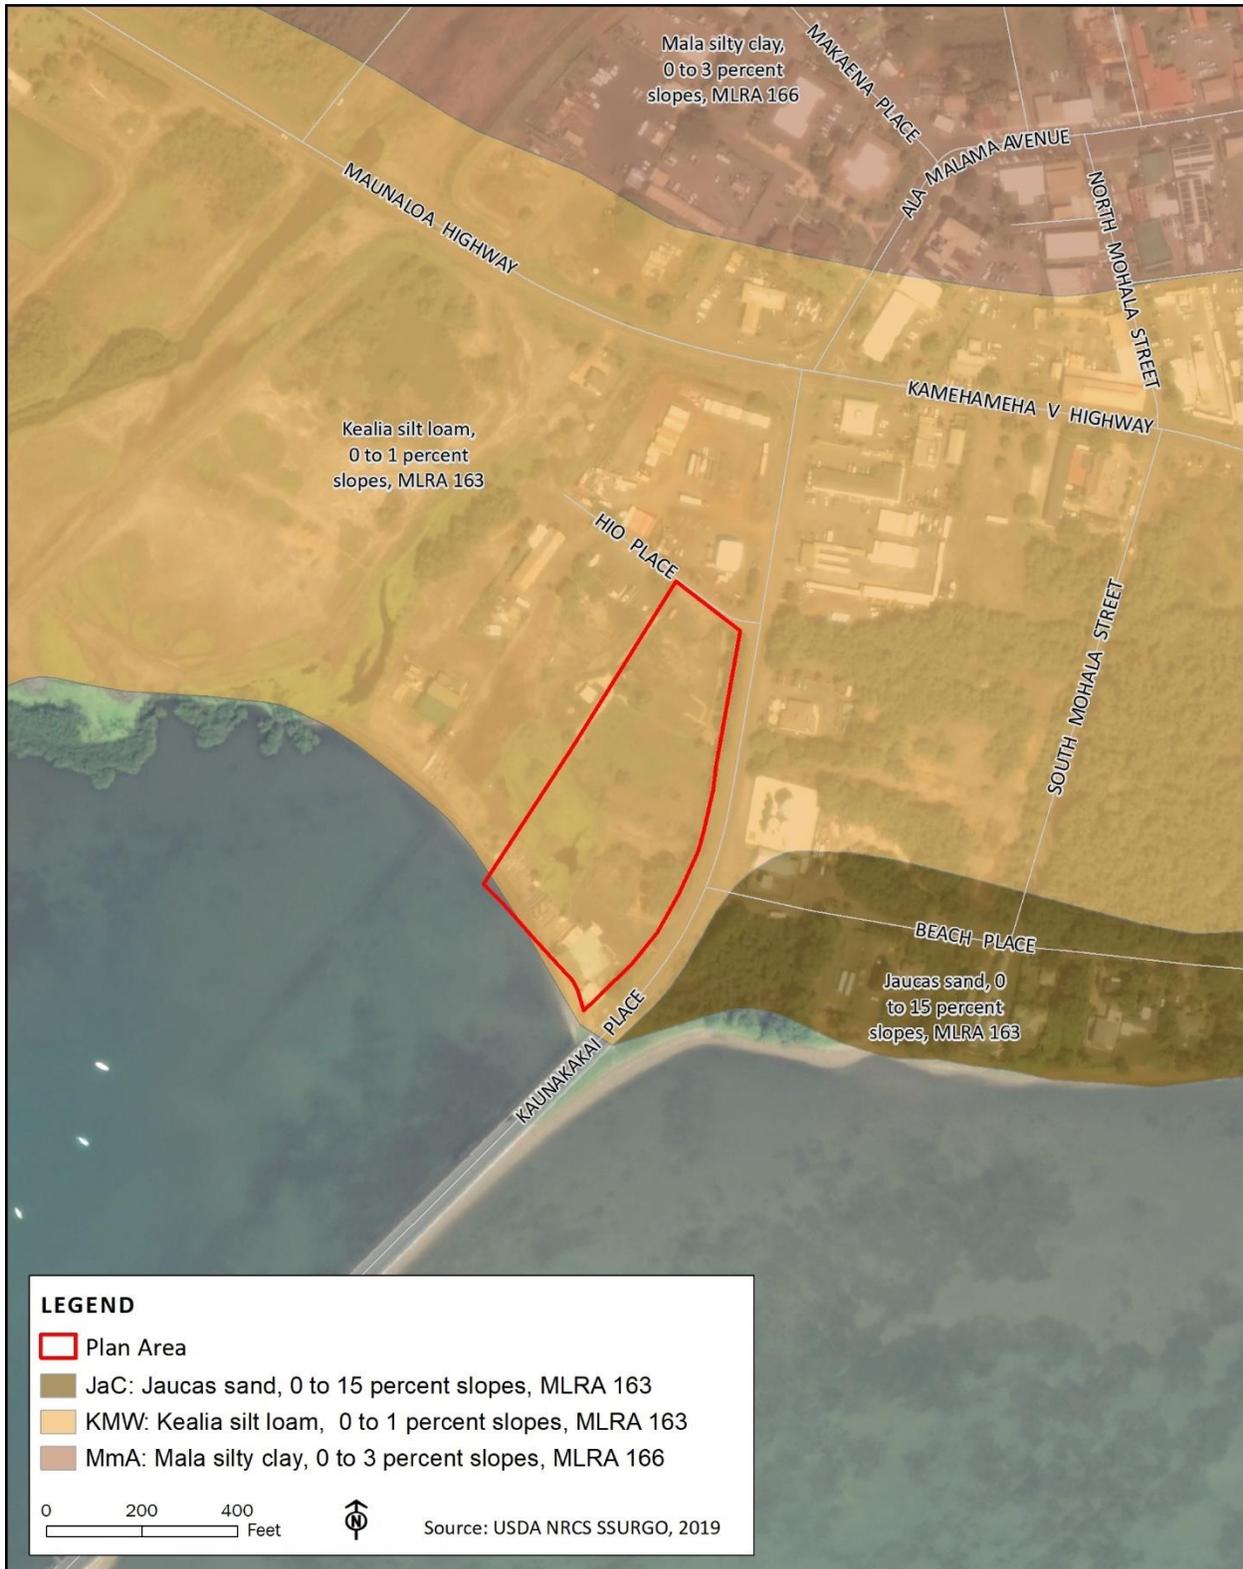
FIGURE 3-31 SOILS

Kealia silt loam (KMW) is uniformly distributed throughout the site (*Figure 3-31*). Kealia silt loam is described as having moderate permeability, high hazard for wind erosion, slow to very slow runoff and no more than slight water erosion hazards. Kealia silt loam is poorly drained and has a high content of salt. Ponding occurs in low areas after a heavy rain. When the soil dries, salt crystals accumulate on the surface. This soil is used for wildlife habitat and pasture, but has low grazing value. It is not used for crops, because of poor drainage and high salt content (Foote et al. 1972).

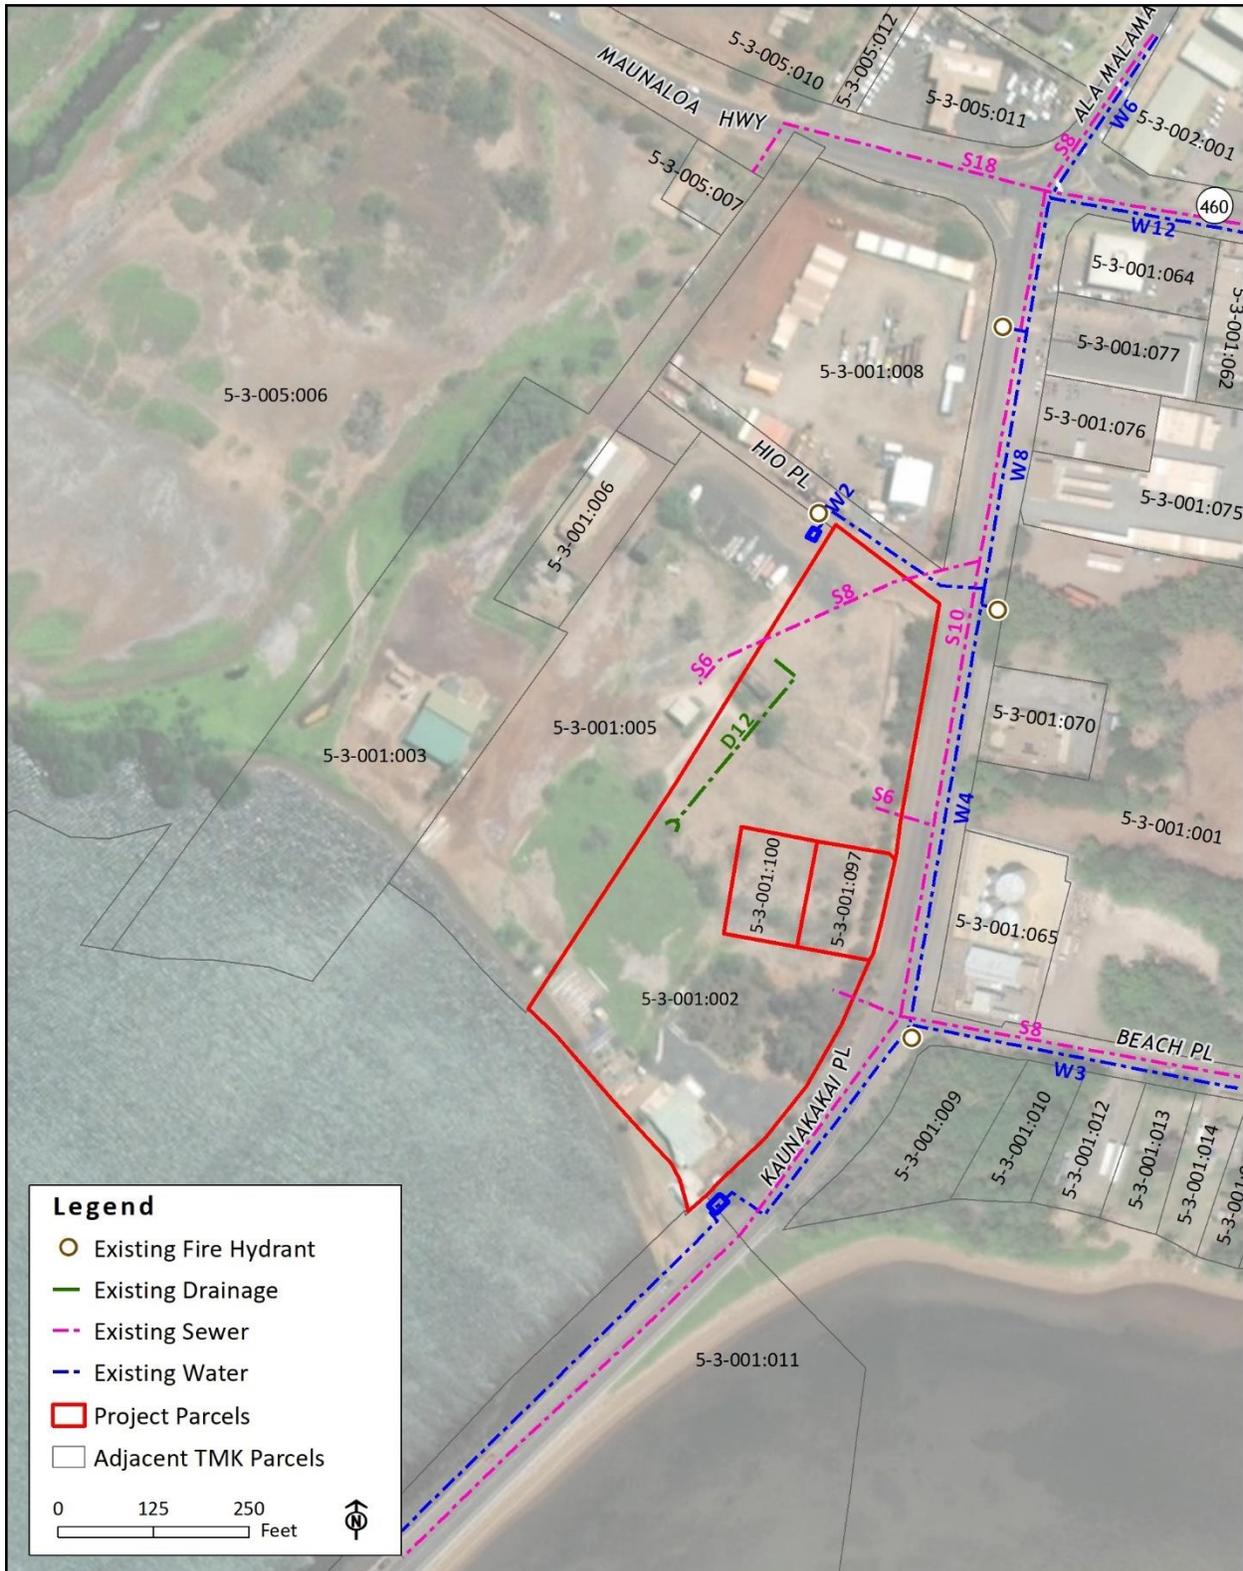
FIGURE 3-42 UTILITIES MAP

An existing irrigation system is located within the Plan Area at the amphitheater and stage area. The existing system is currently nonoperational and is in need of repair, improvements or replacement.

Additional permanent power connections are located on the constructed earth mound for community performances; however the condition of the power connections was in a state of either being intentionally terminated or vandalized. It appears that the source of the power for this system originated from the County side of Malama Cultural Park since an electrical meter was identified in close proximity to the system and near the property line.

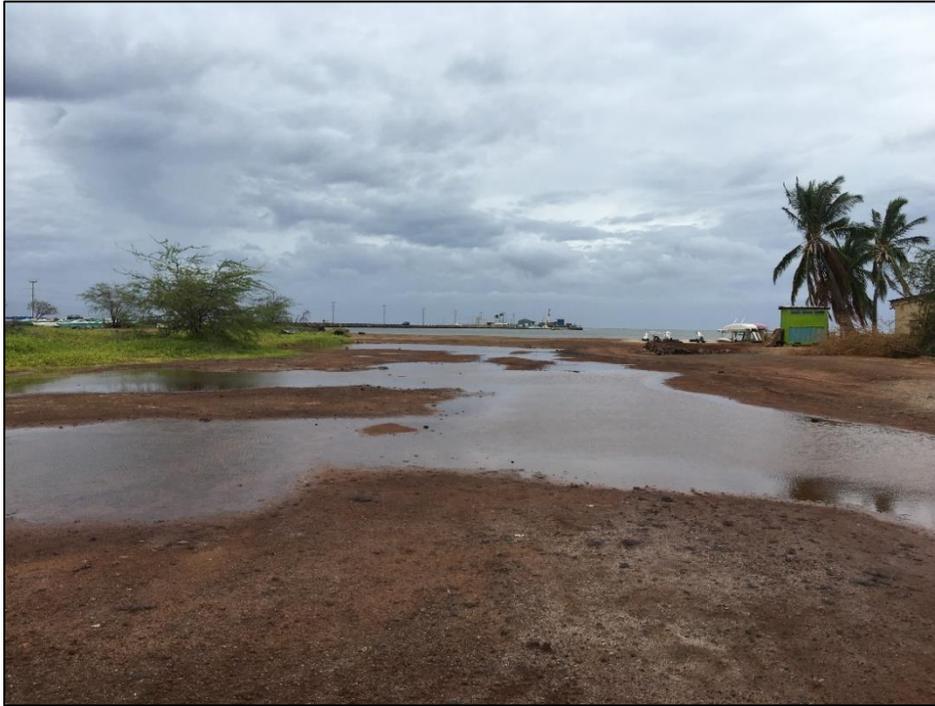
FIGURE 3-43 PONDING OBSERVED ON THE ADJACENT COUNTY PARKING AREA

Site visit observations confirmed known drainage and flooding issues from storm surge, high tides, and coastal flooding for areas of Malama Cultural Park. Low points around the park were identified with ponding conditions from both rainfall runoff during the site visit as well as possible ponding conditions due to wave inundation indicated by salt deposits on the ground surface (*Figure 3-43 and Figure 3-44*).

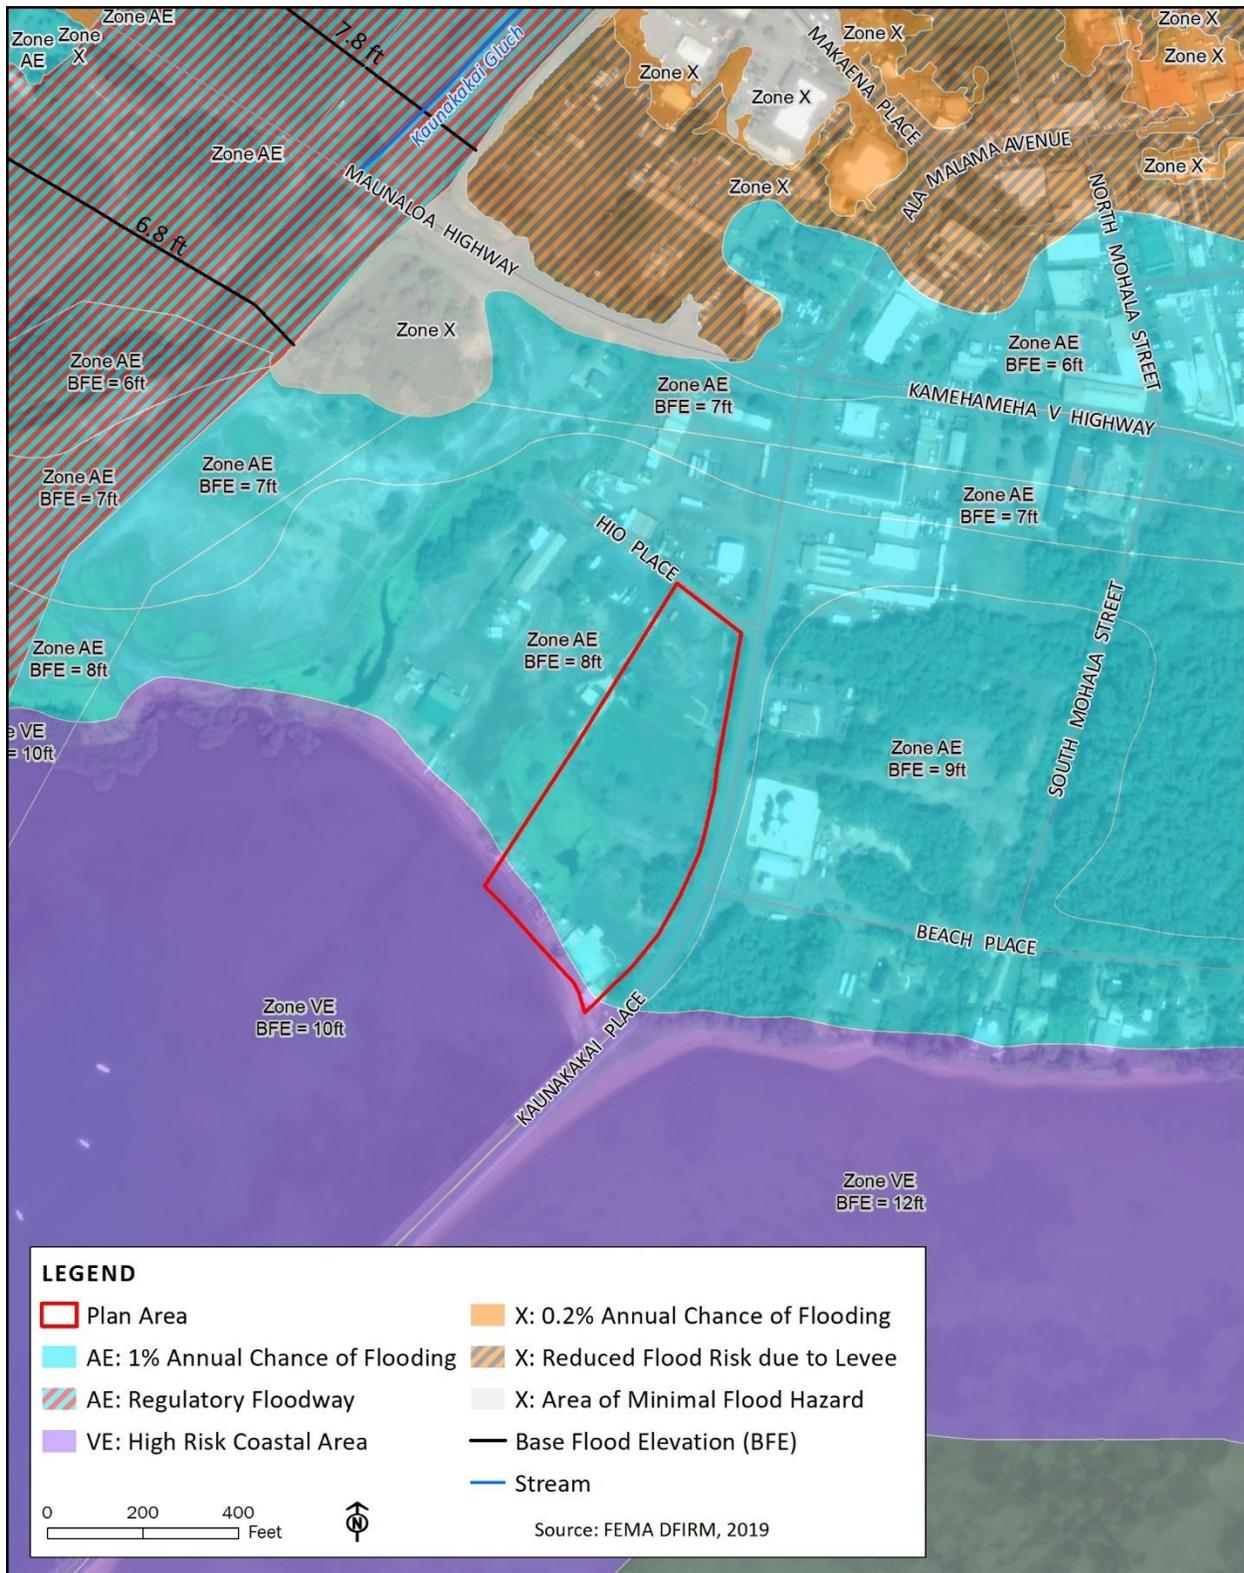
FIGURE 3-45 FLOOD, FEMA DFIRM PANEL NUMBER 15000030189F (11/04/2015)

A portion of the site along the coastline is also located in flood zone VE with a base flood zone elevation of 10'. Areas in zone VE are areas subject to the inundation by the 1% annual chance flood event with additional hazards due to storm-induced velocity wave action.

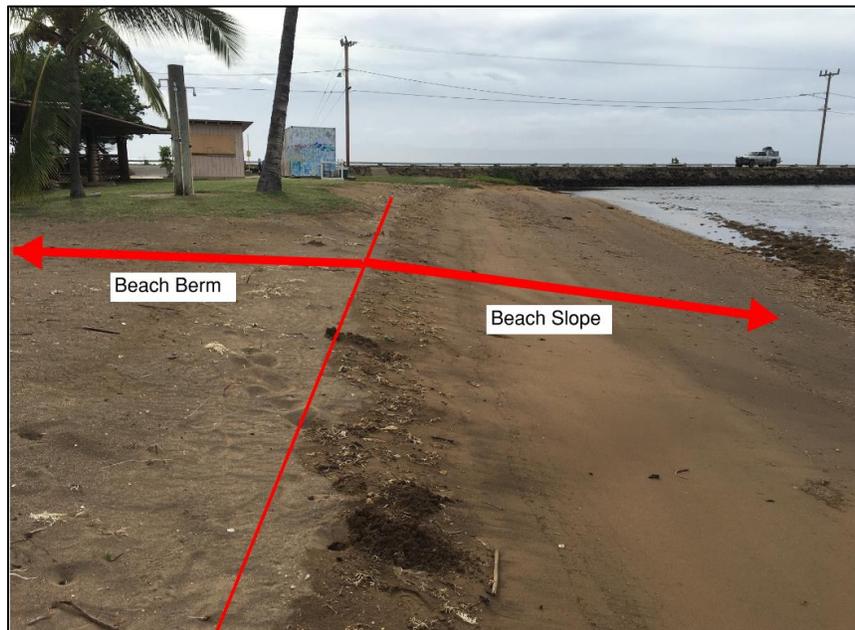
FIGURE 5-2 BEACH BERM LOCATION AT MALAMA CULTURAL PARK

There are multiple options to raise the berm height of the beach, including placement of sand, or placement of sand on top of a solid core such as a geotextile mattress or a rock-filled high-density polyethylene (HDPE) mattress. Placing a buried core in the berm helps to hold the sand in place while providing a solid backstop in extreme erosion events.

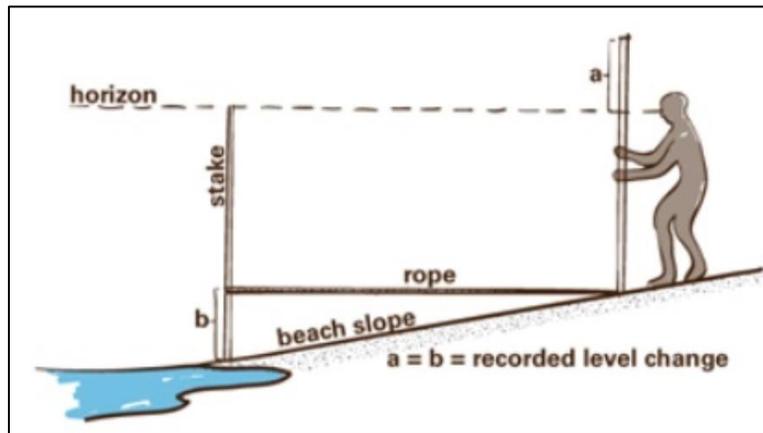
FIGURE 5-4 DIAGRAM OF THE EMORY METHOD FOR COASTAL MONITORING

Routine measurements can be useful for visualizing changes in the beach shape and volume over time. For example, the morphology of the beach during the calmer ocean conditions of summer can be compared to the rougher conditions of the winter swell. Long-term monitoring of the shoreline will reveal trends in overall erosion or accretion of the beach. Monitoring can also identify specific locations on the beach where erosion may be occurring at a faster rate. Longitudinal observations of shoreline data are useful for identifying locations where interventions may be required as well as for evaluating the success of implemented mitigations.

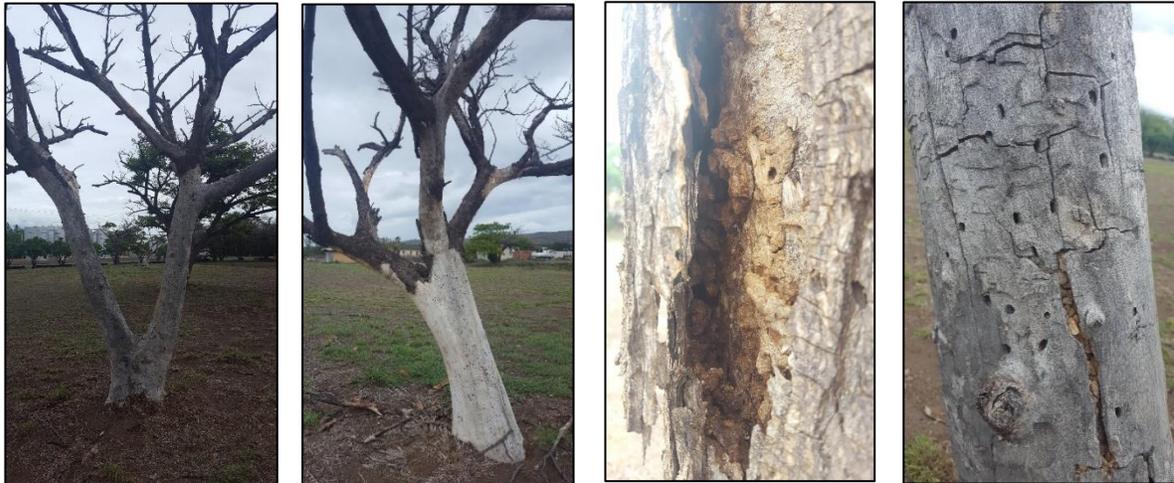
**Figure A8** A row of kiawe trees (*Prosopis pallida*) planted in the central interior of the Park. Three of these trees are dead/dying.

A few of the kiawe trees planted in the central area of the Park were in varying stages of dying. A closer inspection of these trees revealed bark lifting away from the trunk and dozens of boring holes and what appeared to be insect frass, underneath. The observed holes may be attributed to the kiawe round-head borer beetle (*Plascosternus crinicornis*) which is known to damage kiawe wood by boring small holes into its bark; however, no insects were spotted at the time of the survey and the exact cause remains undetermined.

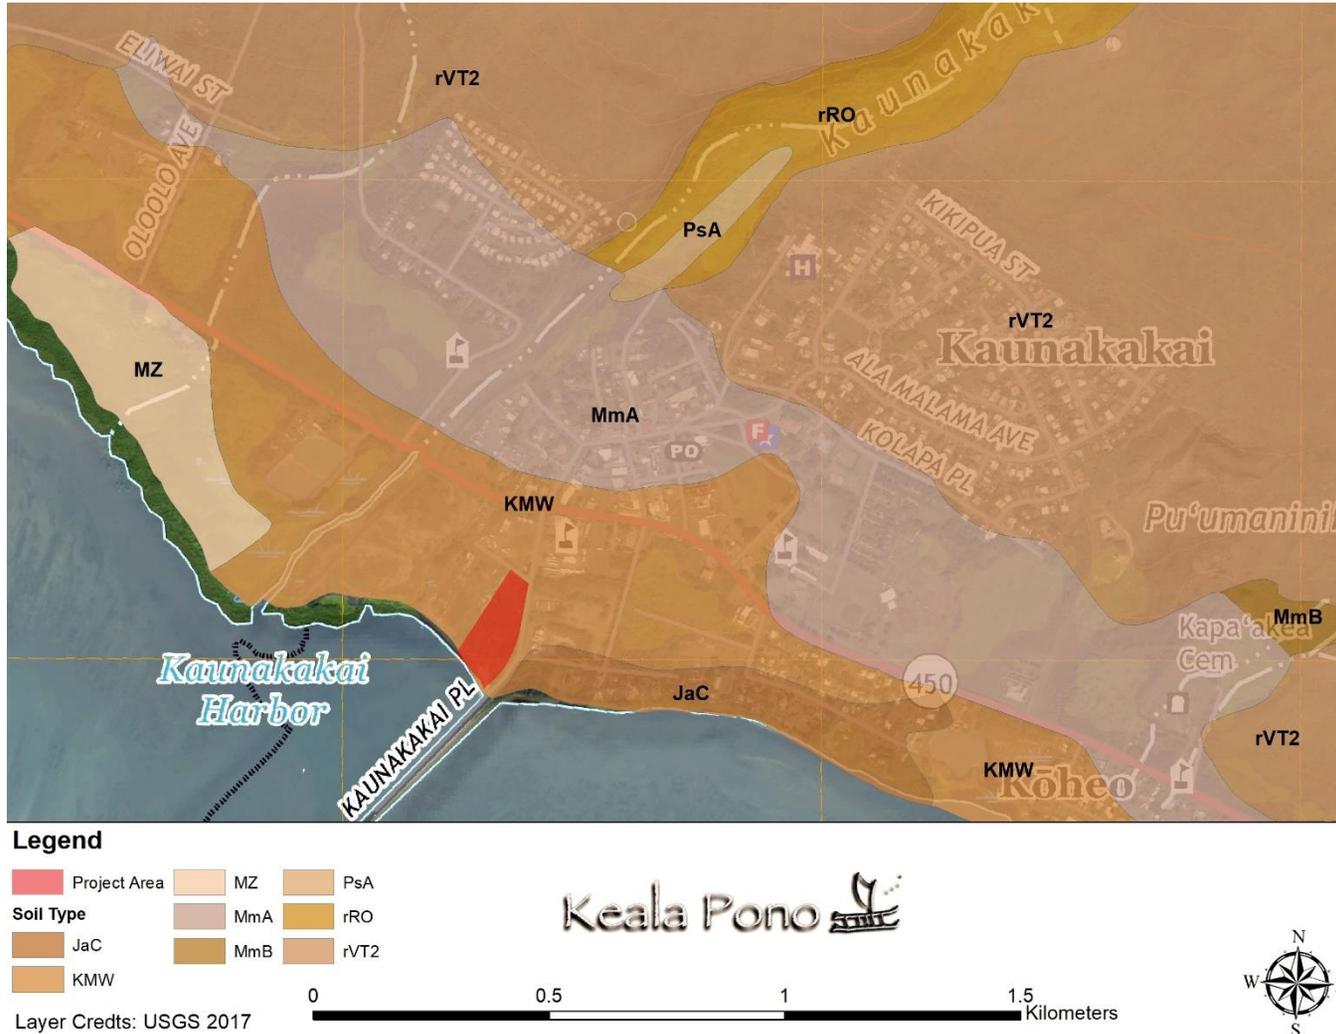
Figure 4. Soils in the vicinity of the project area (data from Foote et al. 1972).

Also in the vicinity are Mala silty clay, 0–3% slopes (MmA) and Mala silty clay, 3–7% slopes (MmB). Smaller sections of Pulehu clay loam, 0–3% slopes (PsA) and rock outcrop (rRO) are

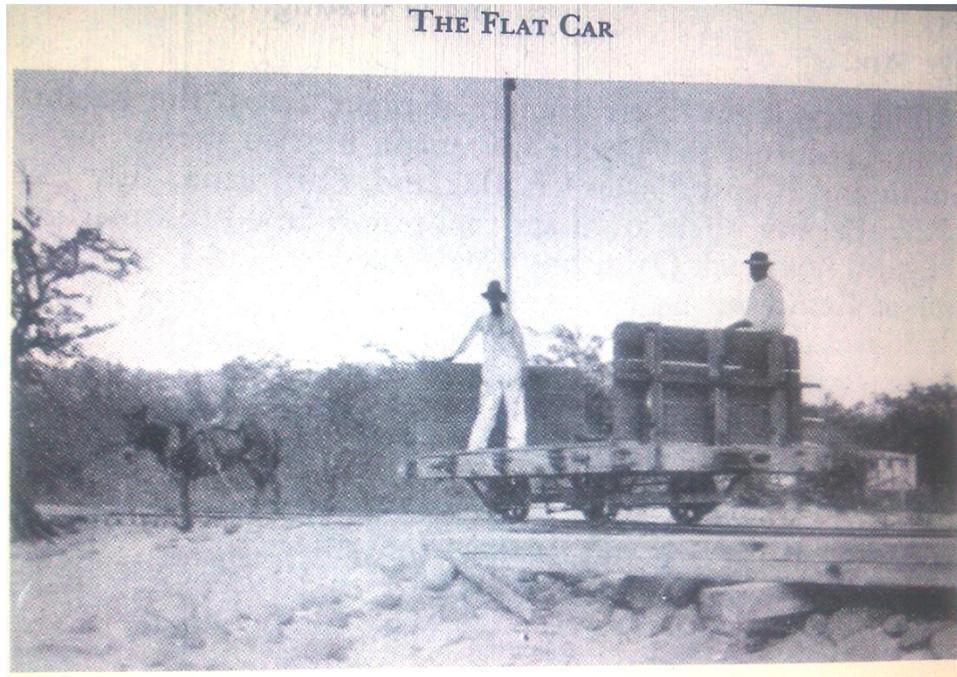
**Figure 15. Photo of the flat car at the Kaunakakai wharf (Cooke 1949:87).**

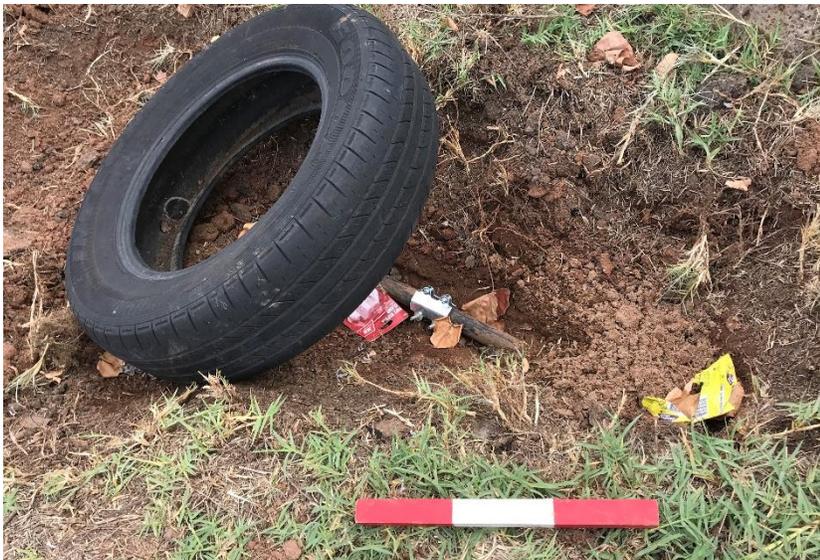
**Figure 31. Existing excavation along the Malama Platform’s makai wall, plan view. The scale is marked in 10 cm increments.**

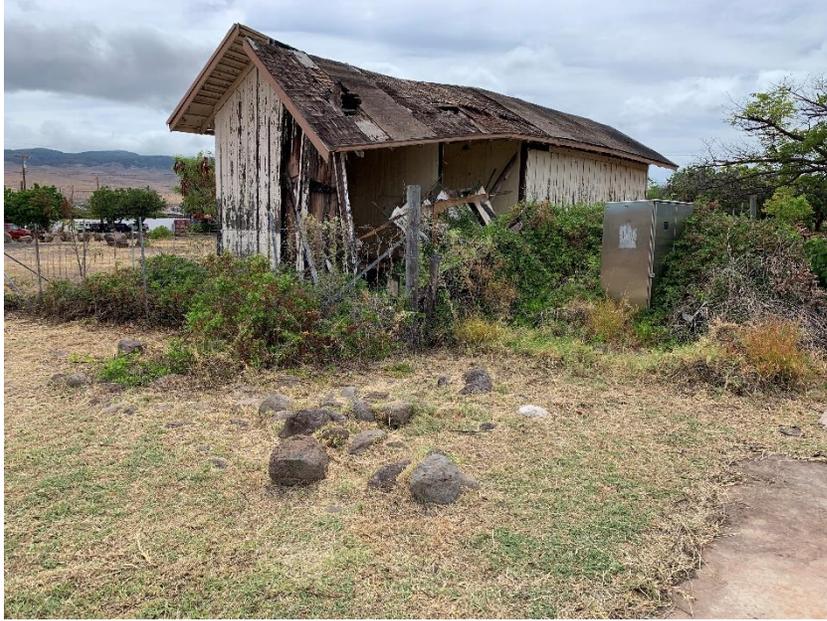
**Figure 36. Makai side of the historic Kaunakakai jailhouse showing the dilapidated condition of the roof and wall; orientation is to the northeast.**
